SERVICE BULLETIN

APPLICABILITY: 2020-23MY Outback & Legacy With 2.4L DIT
2019-23MY Ascent

NUMBER: 09-106-23

SUBJECT: Exhaust Pipe Front (EPF) Design Change

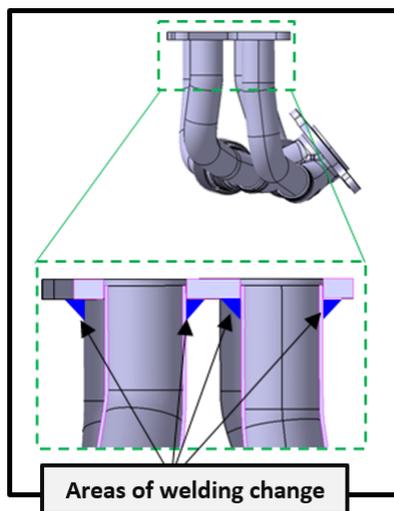
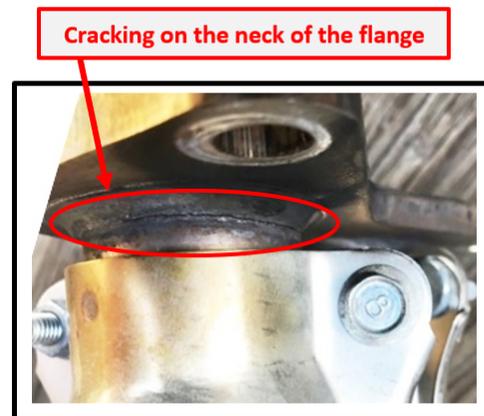
DESCRIPTION OF DESIGN CHANGE:

This bulletin announces design changes made to the Exhaust Pipe Front (EPF) to address concerns of rattle-type or fluttering sounds coming from the undercarriage during acceleration caused by cracking in the EPF. A welding material with enhanced durability has been incorporated into the production of the EPF. If the condition described is confirmed, the EPF should be inspected and if determined necessary, replaced.
