**SERVICE BULLETIN**

**APPLICABILITY:** 2019-23MY Ascent

**NUMBER:** 09-107-23

**SUBJECT:** DTC P2404 / Reprogramming Files

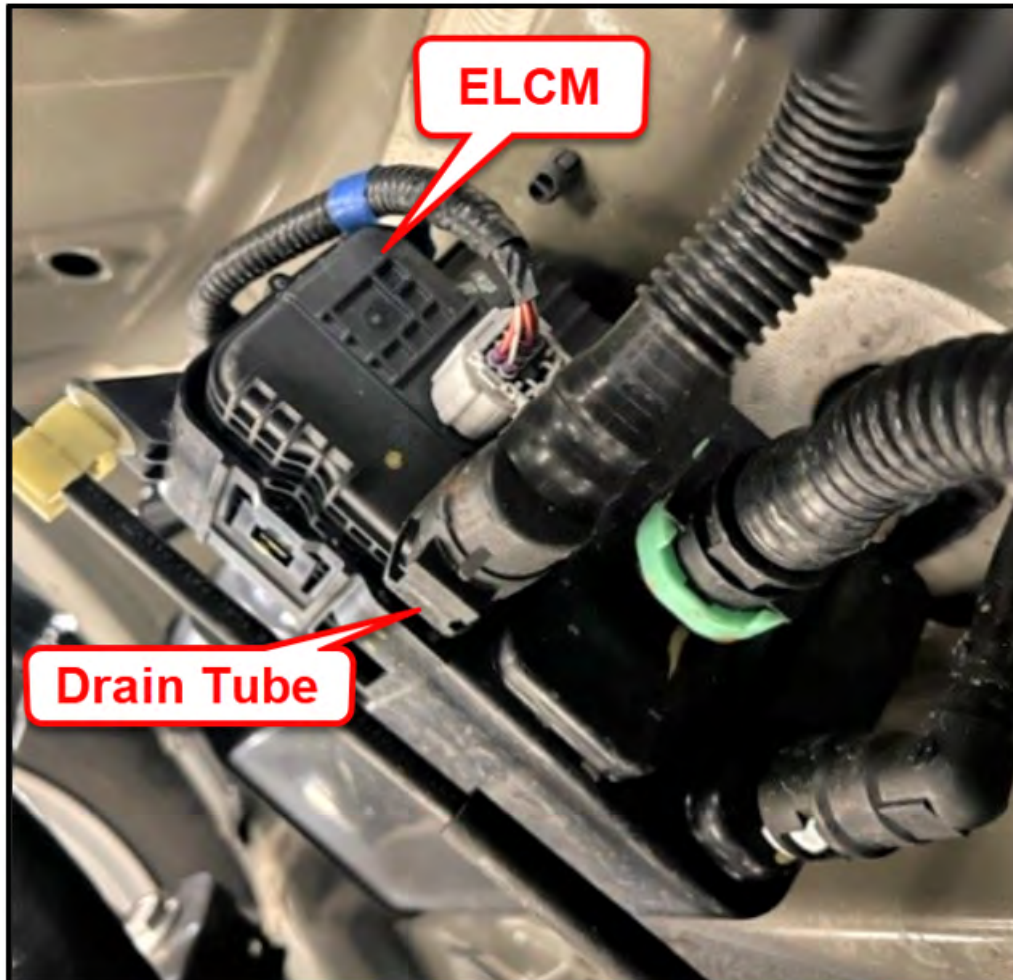
**STEP 5:** **CAREFULLY** disconnect the ELCM drain tube. Inspect for signs of water or oil.

Have signs of water or oil been detected withing the ELCM drain tube?

**YES** – Clean and dry the drain tube using a non-alcohol base cleaner. Proceed to STEP 6.

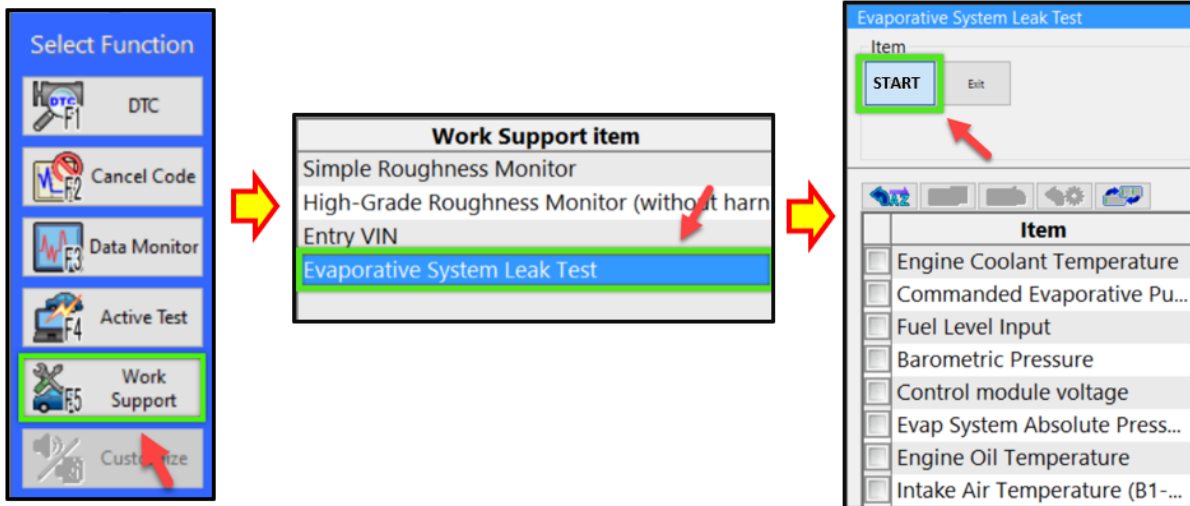
**STEP 6:** Connect the vehicle to a recommended power supply. See **APPENDIX A** for additional information regarding power supply. Using SSM, perform the Evaporative System Leak Test. Collect and save all data.

Once the evaporative system leak test is complete, check the DTCs and examine the vacuum value results. Record the value shown in the row labeled MID: \$3C, TID: \$C4, and Scaling ID: \$FE. This value should be lower than -0.26 PSI.

Value Must Be Lower Than -0.26 PSI

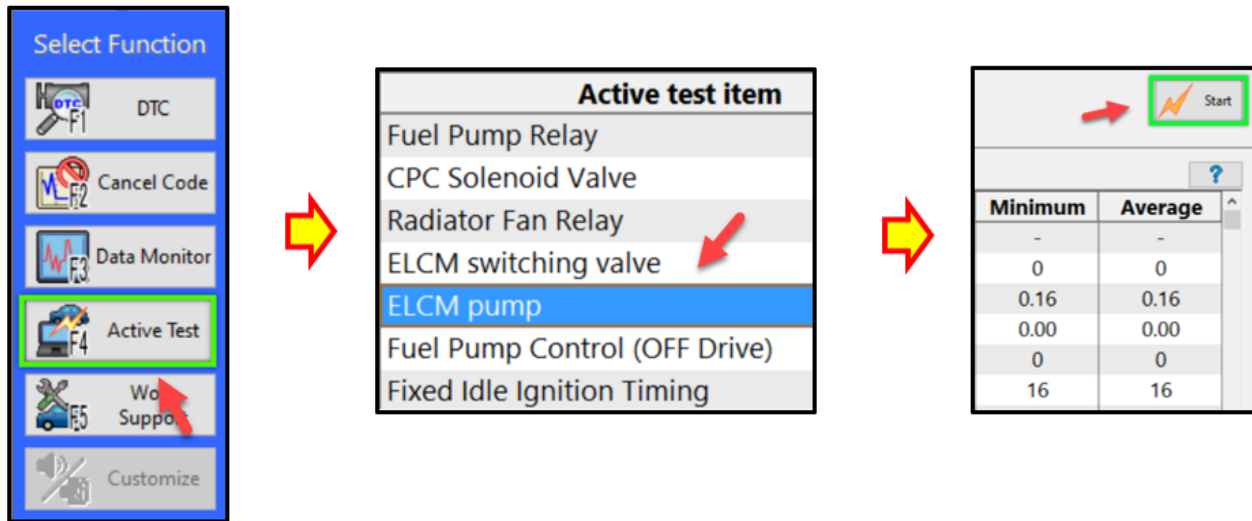
**STEP 8:** Using SSM, perform the ELCM Pump Active Test for a period of 35 minutes or more. See **APPENDIX A** for additional information regarding power supply.

Once the ELCM Pump Active Test has been performed for a period of 35 minutes or more, repeat the Evaporative System Leak Test outlined in STEP 6. Check the DTCs and the vacuum value results.
