SERVICE BULLETIN

APPLICABILITY: 2020-23MY Legacy & Outback 2.4L
2023MY Legacy & Outback 2.5L

NUMBER: 09-108-23

SUBJECT: DTC P2404 / Reprogramming Files

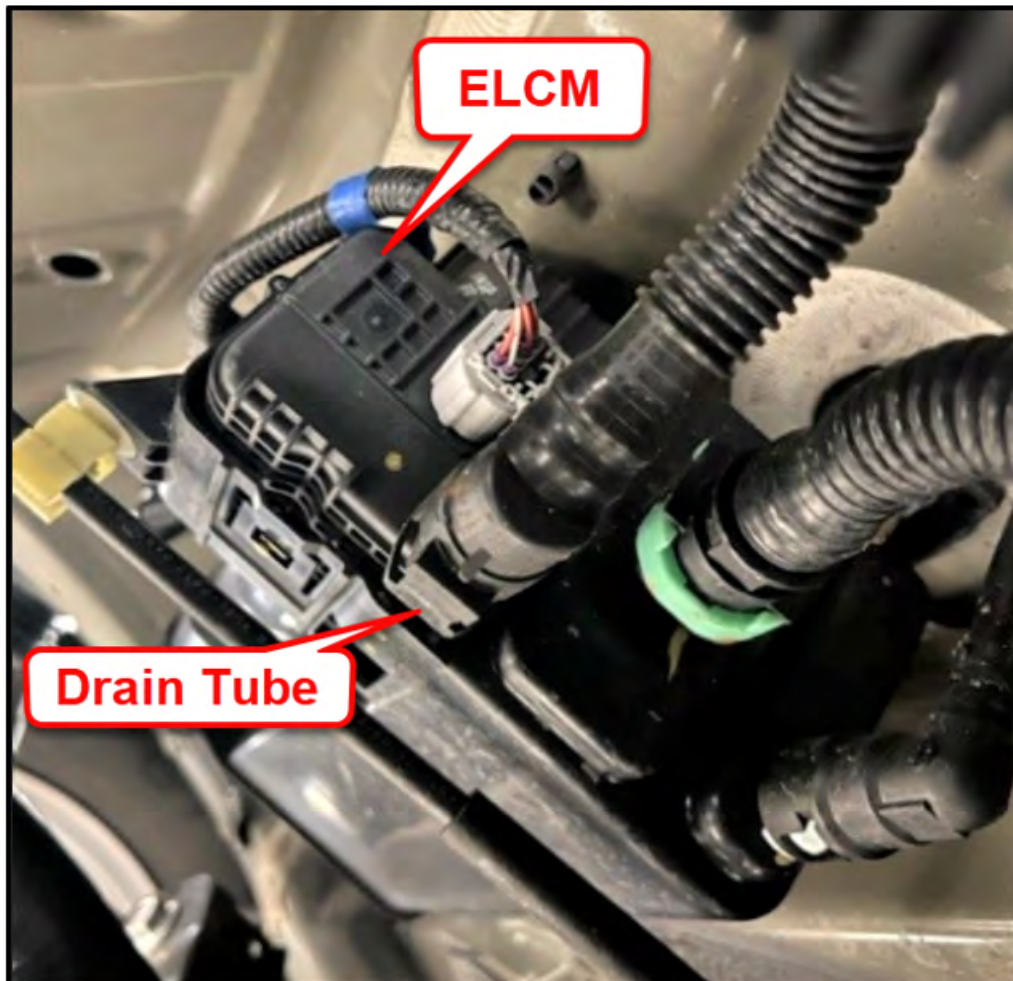
STEP 5: **CAREFULLY** disconnect the ELCM drain tube. Inspect for signs of water or oil.

Have signs of water or oil been detected withing the ELCM drain tube?

YES – Clean and dry the drain tube using a non-alcohol base cleaner. Proceed to STEP 6.

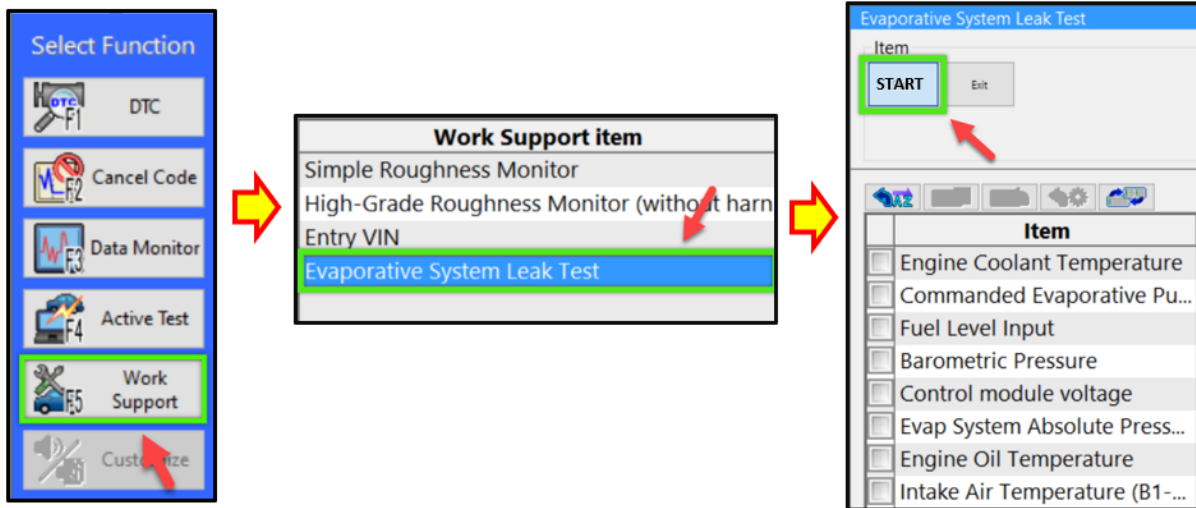
STEP 6: Connect the vehicle to a recommended power supply. See **APPENDIX A** for additional information regarding power supply. Using SSM, perform the Evaporative System Leak Test. Collect and save all data.

Once the evaporative system leak test is complete, check the DTCs and examine the vacuum value results. Record the value shown in the row labeled MID: \$3C, TID: \$C4, and Scaling ID: \$FE. This value should be lower than -0.26 PSI.

Value Must Be Lower Than -0.26 PSI

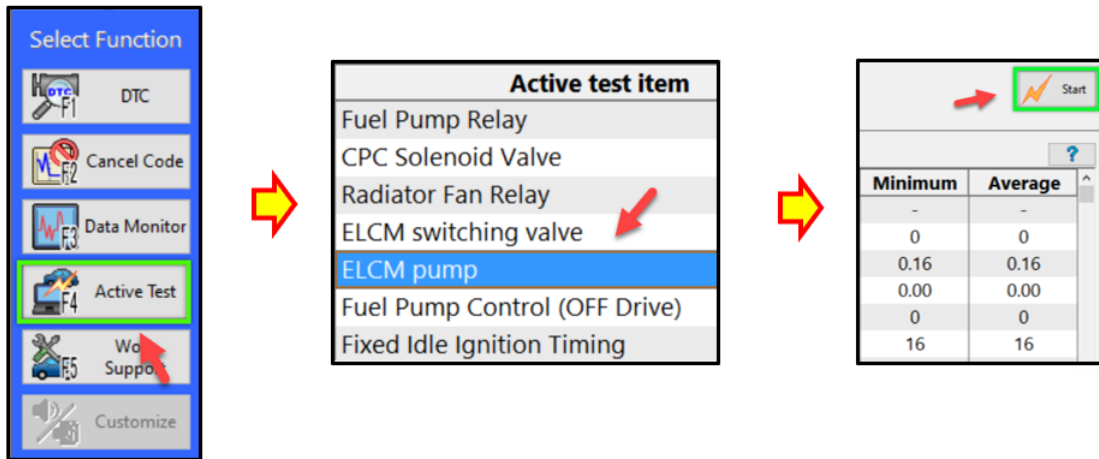
STEP 8: Using SSM, perform the ELCM Pump Active Test for a period of 35 minutes or more. See **APPENDIX A** for additional information regarding power supply.

Once the ELCM Pump Active Test has been performed for a period of 35 minutes or more, repeat the Evaporative System Leak Test outlined in STEP 6. Check the DTCs and the vacuum value results.
