SERVICE INFORMATION BULLETIN

APPLICABILITY: Models with Harman and Denso CP1 Infotainment
NUMBER: 15-304-22R
DATE: 10/11/22
SUBJECT: Procedure for Techline Infotainment Concern Data Collection and Sharing via TechShare
REVISED: 07/31/23

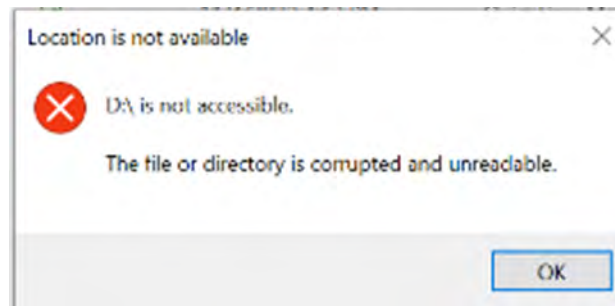
3. Log files are not overly large, 1GB size is sufficient.
4. In case you encounter an error shown below, after accessing USB flash drive from your PC, consider a recovery steps outlined in this section.

a. Recovery steps

- i. Reformat USB Flash drive to NTFS format.
- ii. Write any file under 300MB from PC to the USB flash drive, while it is still inserted in the port.
- iii. Properly remove USB flash drive from PC.
- iv. Repeat the data log collection.
- v. If you are still encountering issues, please use a USB flash drive from another manufacturer.
