SS - 3121 FTL 2023 P4 New Cascadia Detroit FWS Serviceability

P4 New Cascadia vehicles specified with Detroit-Racor Fuel Water Separator and Adaptive Power Steering built since 10/8/2021.

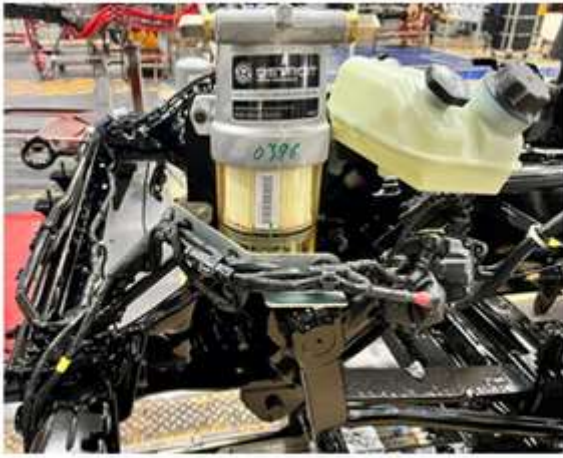
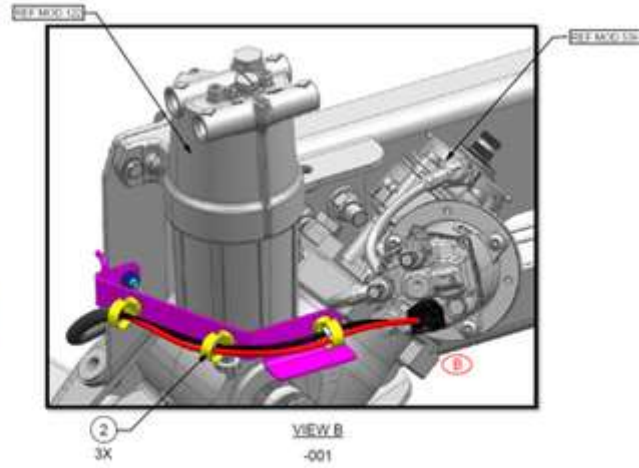
Access to FWS Bowl to replace Filter is reduced due to location of a APS Wiring Bracket.

New Cascadia vehicles specified with Detroit - Racor Fuel Water Separators and Adaptive Power Steering (APS) may have reduced access to service the Fuel Water Separator due to the location of the APS Wiring bracket. Figure 1 shows the current installation of the FWS - APS Wiring and the limited space available for servicing the FWS Assembly-bowl.

Figure 1. Current Detroit-Racor and FWS- APS Wiring Bracket affecting serviceability.

In order to improve the serviceability of the Detroit FWS, the mounting-location of the APS Wiring mounting bracket needs to be relocated to provide better access to the FWS bowl.

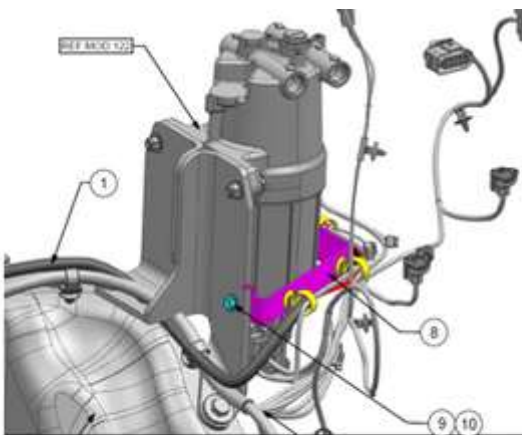
Figure 2. Detroit FWS mounting with APS Wiring mounting bracket, affecting serviceability of FWS.

- Disconnect the APS Wiring connectors
- Remove the APS Wiring mounting Bracket Bolt/Nut, Items 9 and 10 in Figure 2.
- Drop down the APS Wiring - Bracket to open space to access the FWS mounting bracket.
