Technical Service Bulletin

91 MIB3 ASI: Apple CarPlay screen is blank

91 23 14 2065728/5 July 17, 2023. Supersedes Technical Service Bulletin Group 91 number 22-46 dated November 7, 2022 for reasons listed below.

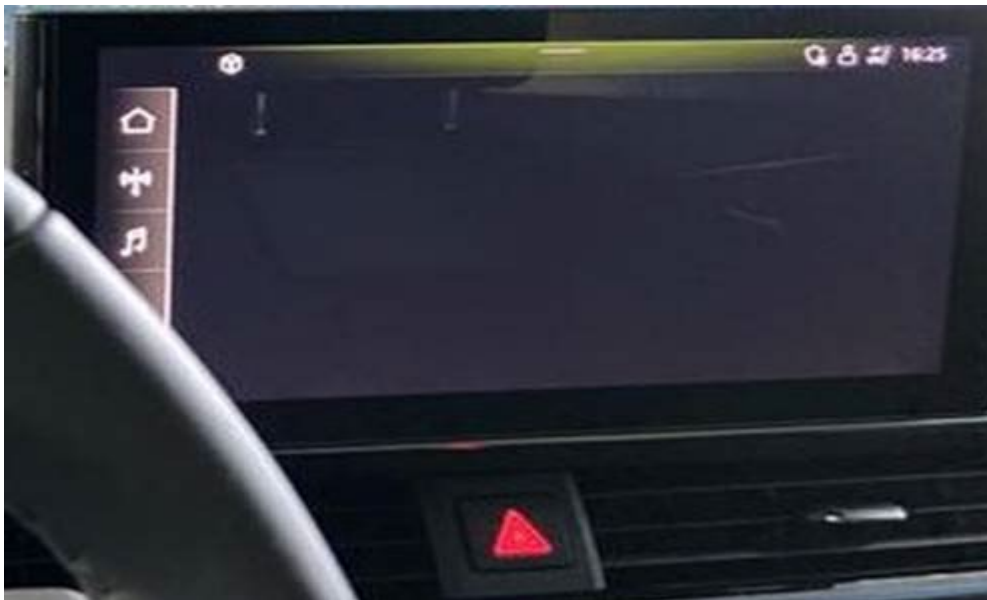
- d (see Figure 1).

Figure 1: ASI display is blank when using wACP.

A non-standard behavior of the current Apple iOS versions (including all 14.x, 15.x, and most 16.x versions) causes the phone to fail to send screen data to the vehicle. Additionally, a hardware issue in iPhone 8, iPhone X, and iPhone XR models can cause the display to blank out.

1. Do not perform any repairs. Any repairs for this concern may be denied.
2. **For customers with iPhone 8, iPhone X, and iPhone XR:**
The problem is due to a hardware issue in the WiFi chipset of the listed phone models. As those phone models are already out of production, no repair will be available. It is advisable to use a wired connection to use Apple CarPlay for those models.
3. **All other iPhone models:**
Please inform the customer that this behavior is due to a bug in the phone's operating system (iOS). **The iOS bug is fixed in iOS version 16.5 or newer.**

In some cases, going to the home menu by clicking the home shortcut on the left of the screen and then reentering ASI resolves the concern. In other cases, the phone might need to be disconnected and then reconnected.
