MBUX multimedia system: The central display is dark, various other system complaints

Topic number	LI82.85-P-071623
Version	4
Function group	82.85 - Navigation and Communication systems
Date	2/24/22
Validity	Model series 167 with code 548/549
Reason for change	Remedy updated

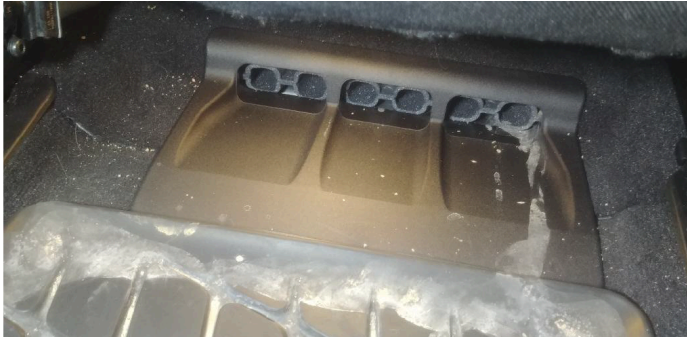
Water ingress through the air vent under the front passenger seat (see attached, note that the vents are facing the rear

of the vehicle). As a result, the head unit (A26/17) may become damaged.

Inspect the MBUX multimedia system (A16/17) hardware, including all attached wiring and connectors, for traces of water and/or corrosion (see attached picture for example).

Attachments	
File	Description
MBUX control unit with visible traces of water intrusion.jpg	An example of signs of liquid intrusion into passenger HVAC vent

Avoid using rubber floor mats for the second row seats on which water can collect and subsequently enter the air vent under the front passenger seat.

An optimized cover is now available for the air vent under the front passenger seat (see parts note). To avoid a recurrence of water damage, install this cover.

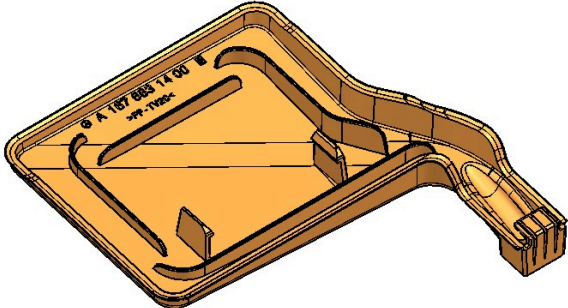
Attachments	
File	Description
air vent cover A1676831400.jpg

Optimized air vent cover
