## Technical Service Bulletin

GROUP	NUMBER
<b>BODY ELECTRICAL</b>	<b>23-BE-009H</b>
DATE	MODEL(S)
<b>JULY 2023</b>	<b>VENUE (QX)</b>

**SUBJECT:** HORN ASSEMBLY WARRANTY EXTENSION (TXXU) AND REPLACEMENT

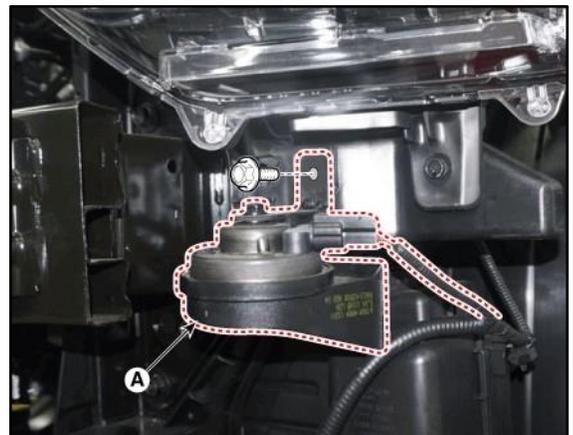
**Description:** Certain 2020-22MY Venue (QX) vehicles may experience an inoperable horn that may be caused by foreign substances causing internal parts to oxidize.

2. Remove the horn (A) after disconnecting the horn connector and loosening the mounting bolt.

(Refer to “Body Electrical System – Horn” for procedure)
