Service Bulletin

Bulletin No.: 19-NA-129

Subject: Squeak and/or Clunking Noise from Rear of Vehicle

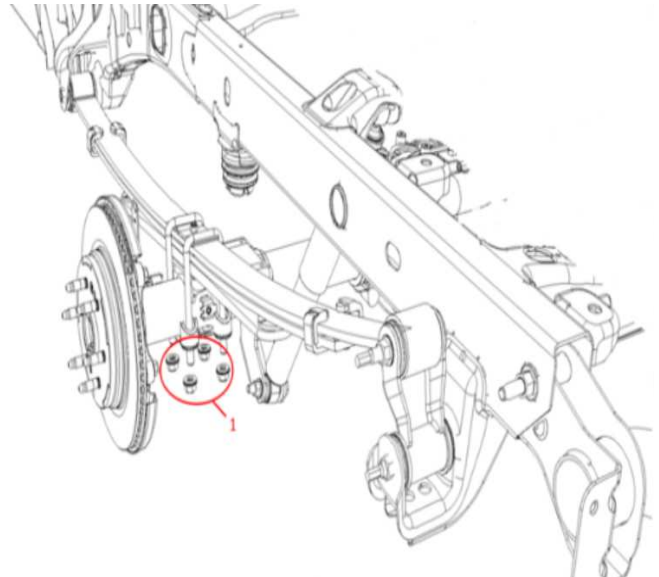
5357922

Caution: Ensure that the proper torque procedure for the U-Bolts is followed in SI. Excessive fastener torque will extrude, and damage, the spring isolators making the condition worse.

2. Loosen the anchor plate U-bolts (1).

3. Re-torque the anchor plate U-bolts (1). Refer to Fastener Specifications in SI.
4. Repeat steps # 2 and 3 for the opposite side leaf spring.
5. Re-test the vehicle for the same clunking noise. If the issue remains, follow the regular repair procedure.
