Service Bulletin

Bulletin No.: 20-NA-142

Subject: Shudder/Surging While Driving

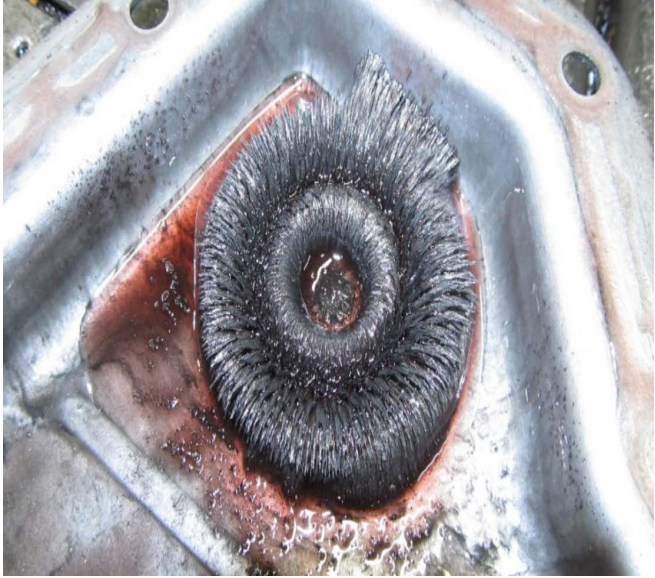
<p style="text-align: right;">5360216</p> <ul style="list-style-type: none"> • If metallic debris is present (similar to graphic above), remove transmission and replace the torque converter and replace the transmission filter. Refer to Torque Converter Replacement in SI. • If metallic debris is not present, drain and clean the oil pan, replace transmission fluid filter and reinstall transmission oil pan following Service Information and follow the Service Procedure below that corresponds with the vehicle fill setup.
