# Service Bulletin

Bulletin No.: 20-NA-175

**Subject: Vertical Misalignment Between Cab and Pickup Box on Driver Side of Vehicle**

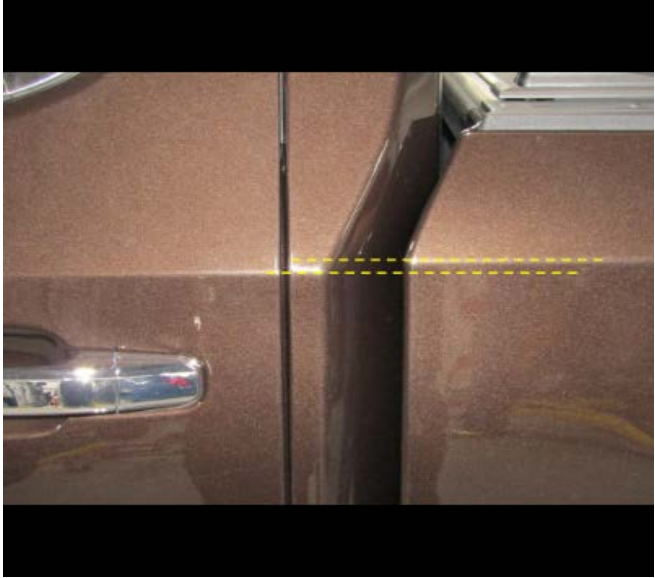
<p style="text-align: right;">5645798</p> <p>Some customers may comment on noticing anywhere from 2 –10 mm (0.08 – 0.4 in.) vertical misalignment of the body feature line between the cab and the pickup box, on the driver's side of vehicle.</p>
<p>Cause</p>	<p>The cause of the condition may be pickup box structure variation.</p>
<p>Correction</p>	<p>Realign the left side of the cab and install shim washers, following the steps in the Service Procedure below.</p>
