Technical Service Bulletin

91 No diagnostics communication to the telematics control module (ConBox); DTC U142100

91 23 15 2070942/1 July 19, 2023.

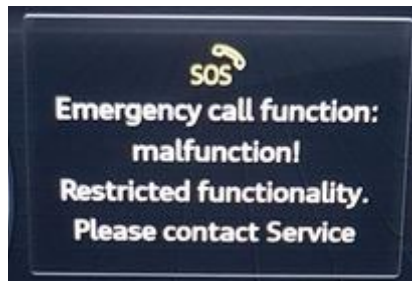
- An SOS Warning might be displayed in the instrument cluster (Figure 1).

Figure 1. Emergency call malfunction warning.

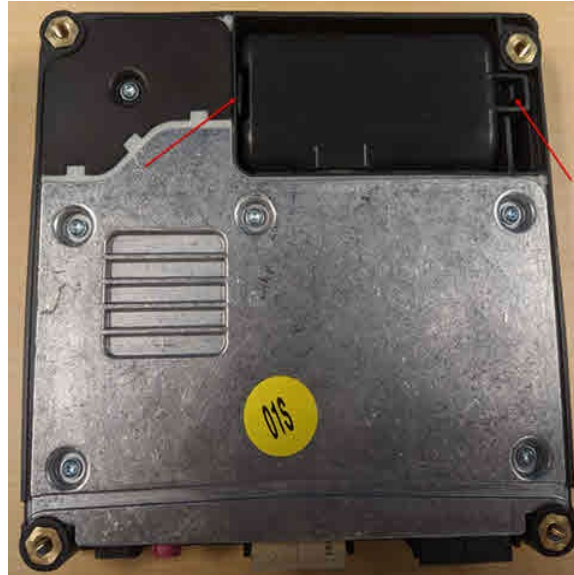
Figure 2. Backup battery compartment location.

2. Open the battery compartment of the control module for the emergency call module and communication unit, J949 (address word 0075), and disconnect the backup battery (Figures 2 - 3).

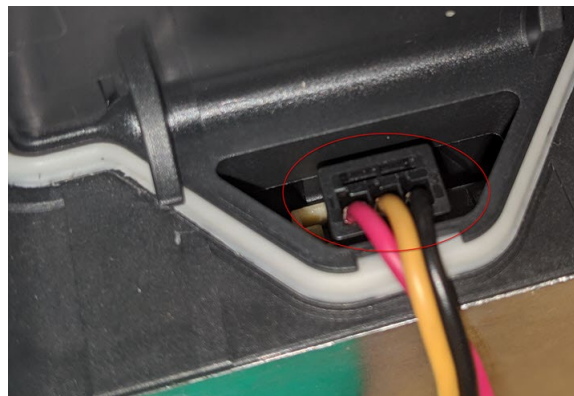
Figure 3. Backup battery connector (no release mechanism).

5. Wait approximately one minute, then reinstall the backup battery back into the control module for the emergency call module and communication unit, -J949- (address word 0075).
6. Reinstall the control module for the emergency call module and communication unit, -J949- (address word 0075) back into the vehicle.
7. If ODIS **still cannot** connect to the control module for the emergency call module and communication unit, - J949- (address word 0075), then follow the ODIS test plan and replace the control module for the emergency call module and communication unit with the part specified in ETKA.
