PANORAMIC ROOF OPENING PANEL AND/OR ROOF BLIND ONE TOUCH INOPERATIVE

Range Rover
• 23MY Velar

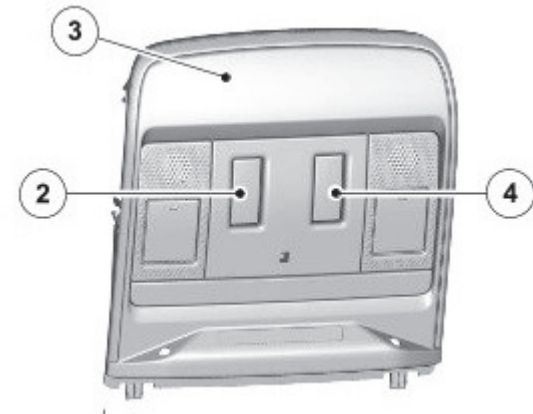
- The roof opening panel blind will not automatically open when the roof opening panel is requested to the tilt or open positions.

- The roof opening blind motors may have been built with incorrect software.

- **SSM 76030** has been published to address this concern.
- Both roof opening panel blind motors (LR157828) will require replacement.
