TECHNICAL SERVICE BULLETIN

Equipped With Subwoofer - Rattle From Right Loadspace Trim Panel At High Audio System Volumes - Built On Or Before 20-Mar-2023

23-2241
27 July 2023

Ford 2021-2023 Bronco	Built on or before 20-Mar-2023 Equipped with a factory subwoofer
---------------------------------	---

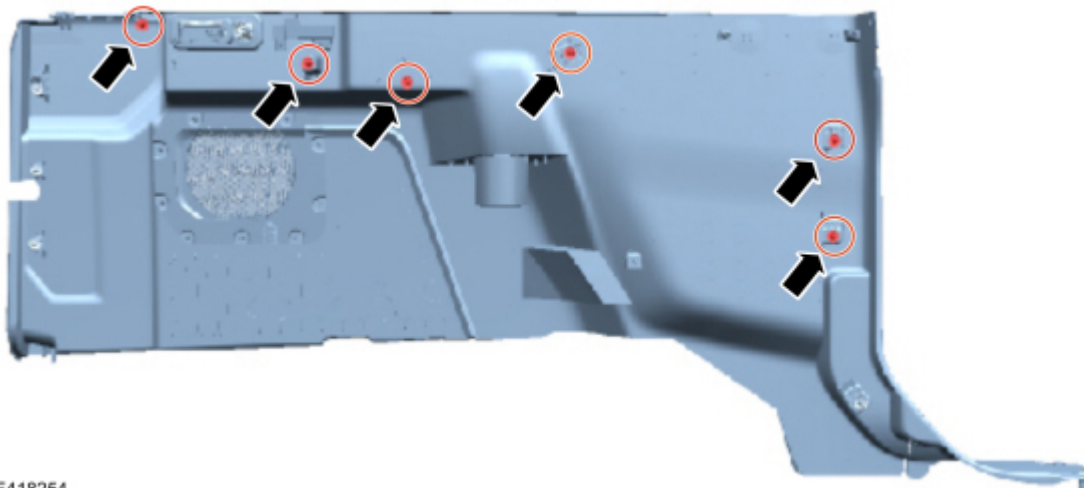
Figure 1 - 3-Door Shown, 6 tree fasteners must be replaced

1. Remove the right loadspace trim panel. Refer to the Workshop Manual (WSM), Section 501-05.
2. Remove and discard the existing tree fasteners on the right loadspace trim panel then install the new tree fasteners. 3-door vehicles require replacement of 6 tree fasteners. 5-door vehicles require replacement of 5 tree fasteners. Refer to Figures 1 and 2 for fastener locations.

NOTE: The new tree fasteners will be blue in color.

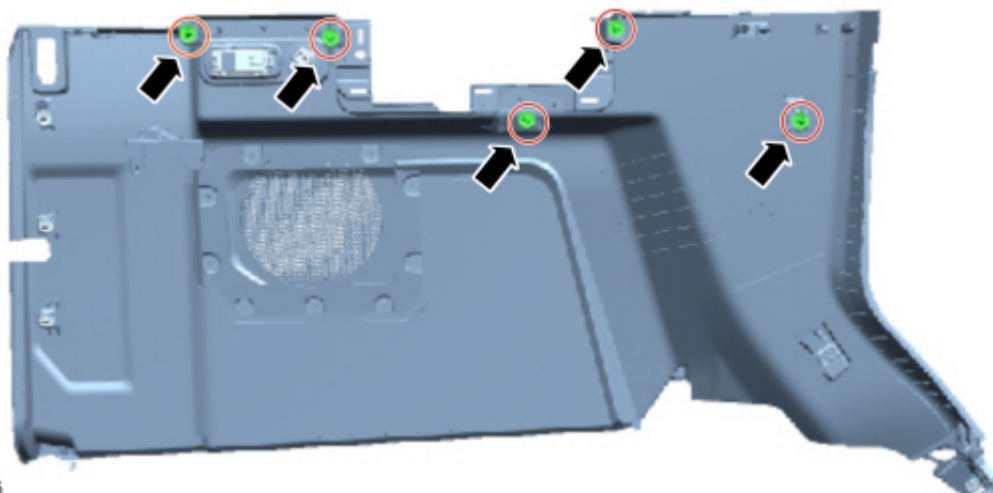
Figure 2 - 5-Door Shown, 5 tree fasteners must be replaced
