## Possible Validation of Errors P1074 and P0476, Exhaust Butterfly Valve

Diavel V4 Model Year 2023 (all model versions)

Tips&Tricks Bulletin SRV-TTB-23-002

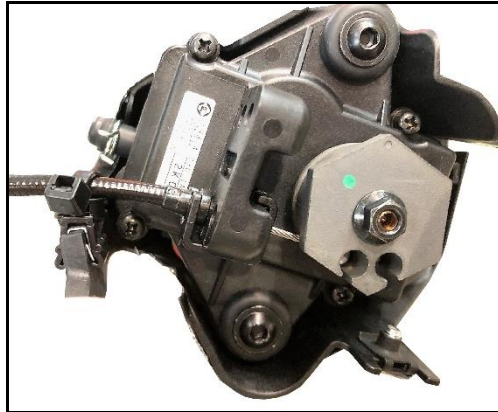
- Remove the left belly fairing cover and remove the exhaust butterfly valve motor without removing the Bowden cable. **Take a picture of the motor pulley to clearly show the position found at the time of the fault (see example below).**

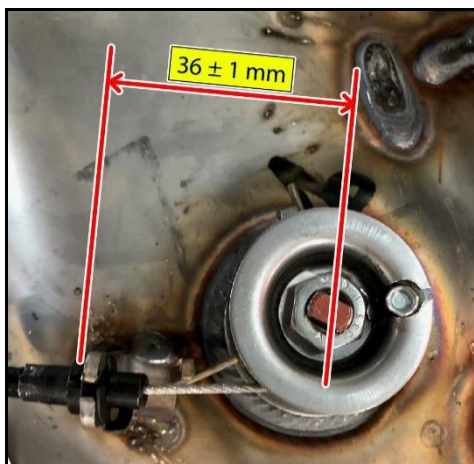
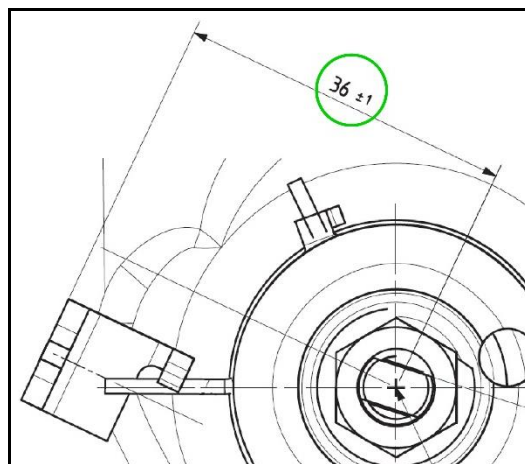
**The defect may be caused by an incorrect position of the Bowden cable retaining bracket on the exhaust silencer. In some cases, we have found that the bracket is too far away from the motor pulley, creating a condition of limited travel.**

Measure the distance between the center of the pulley and the Bowden cable support bracket. Check that it is  **$36 \pm 1$  mm (be careful as taking this measurement must be precise)**.

If this value is not correct, assess whether it is possible to slightly bend the bracket (normally in the direction of the pulley) to bring the gap back to the nominal value or whether it is necessary to replace the complete silencer.

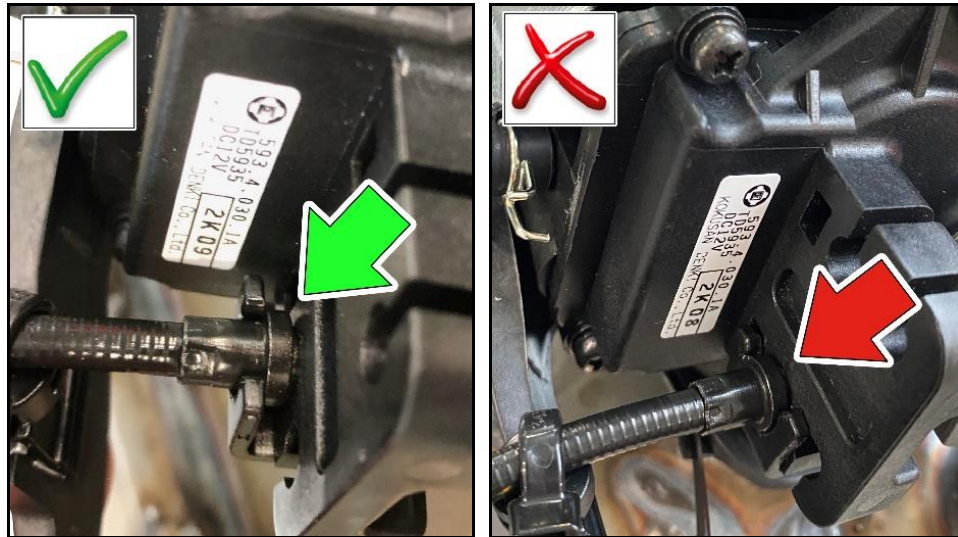
- In any case, during removal and upon refitting, make sure that the plastic clip preventing the sheath from falling out of the motor housing is present and in position, and that the ring nut with reduction at the end of the sheath is in place and correctly fitted.

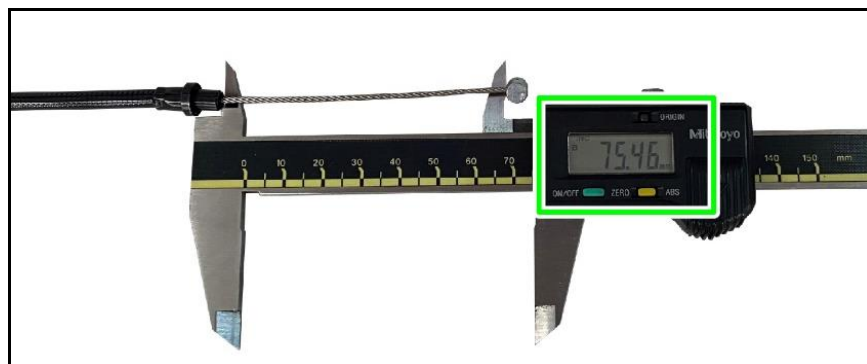
- Verify the Bowden cable is within tolerance. Measure from the end of the sheath to the cylinder retaining it to the pulley and/or valve and check that the length is  $75.4 \pm 1$  mm.
