## **Service Bulletin**

Bulletin No.: 22-NA-232

Date: August, 2023

Subject: Diagnostic Tip for 10 Speed Oil Pump Drive Gear

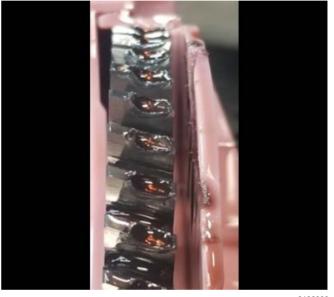
6196003

Note the damage to the oil pump idler gear.

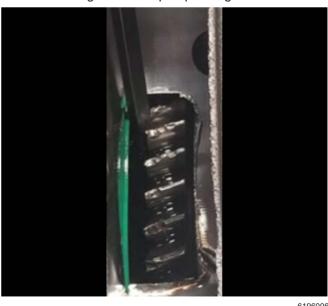
6196006

Note the side-to-side movement in the oil pump idler gear.

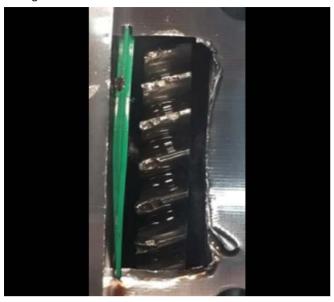
6196005

Note the damage to the oil pump driven gear.
