Technical Service Bulletin

Subject: CREAK OR SQUEAK NOISE FROM FRONT OF VEHICLE WHEN TRAVELING OVER A BUMP WHILE TURNING AT LOW-SPEED	Bulletin No.: 02-002/23
	Last Issued : 07/05/2023

2024 CX-90

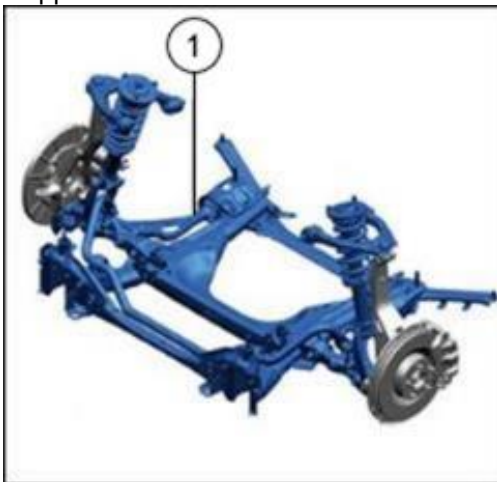
Some vehicles may exhibit a creaking or squeaking noise from the front of the vehicle when traveling over a bump while turning at low-speed. This is caused by a stick-slip phenomenon occurring between the rubber bushing and the stopper on the rear of the front lower arm (1). A mass production change is under study.

Customers having this concern should have their vehicle repaired using the following repair procedure.
