Subject: ABNORMAL NOISE WHEN OPERATING ELECTRIC STEERING TILT/TELESCOPIC FUNCTION	Bulletin No.: 06-003/23
	Last Issued : 07/11/2023

2024 CX-90 (with electric tilt/telescopic steering) with VINS lower than JM3KK*****107178 (produced before March 24, 2023)

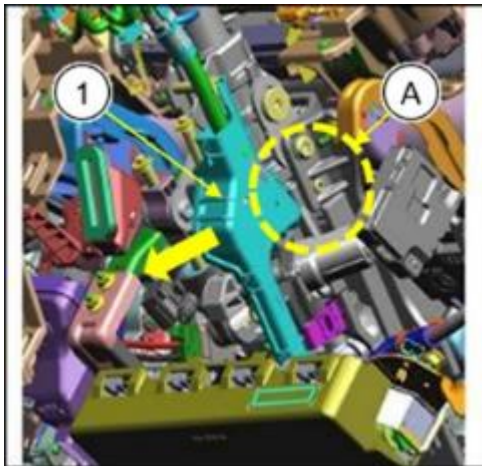
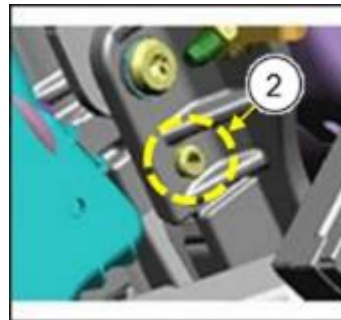
Some vehicles may exhibit an abnormal noise (creaking noise) when operating the electric steering tilt/telescopic function. This is caused by adhesion and slippage occur repeatedly between the steering column and the set screw due to over tightening of a set screw in the steering tilt/telescopic mechanism. To eliminate this concern, the tightening amount (torque) of the set screw has been changed.

c. Move the wire harness cover (1) toward the yellow arrow, then loosen the set screw (2) 90 (+/- 10) degrees using a hexagonal wrench.
