# Technical Service Bulletin

<b>Subject:</b>  CREAKING NOISE FROM STEERING COLUMN	<b>Bulletin No.:</b> 06-004/23
	<b>Last Issued :</b> 07/17/2023

2016-2023 CX-9 vehicles with VINs lower than JM3 TC\*\*\*\* \*\* 657869 (Produced before Mar. 13, 2023)

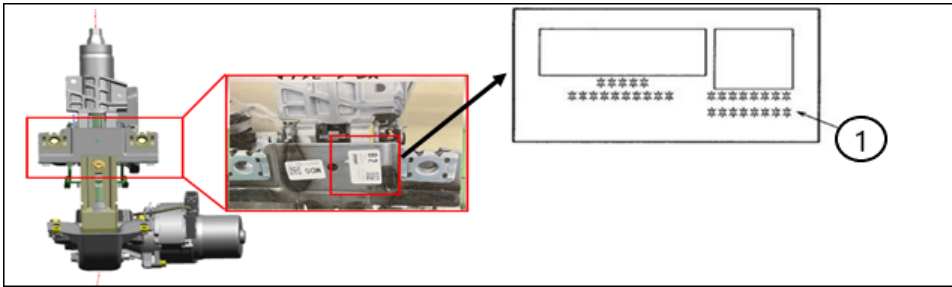
Verify the lot number printed on the sticker (1).

The first digit indicates the year of the production date, the second is the month, the third and the fourth are the day.

**NOTE:** From January to September, the months are represented with their correspondent number (from 1 to 9). The

remaining months are represented by a letter (October=X, November=Y, December=Z).
