Bulletin #: 2116.2

Part ID: 6924

Red Warning in the Instrument Cluster: Occupant Seat Belt not Fastened

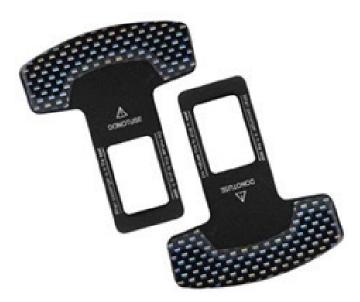
- 1. The belt buckle is faulty,
- 2. The vehicle is moving at a speed greater than 18 mph (30 km/h) and an occupant does not have their seat belt fastened, or
- 3. The vehicle detects improper use of the seat belt by the driver (e.g., use of a dummy belt buckle).

1. Document the presence of any "dummy" seat belt buckles in the vehicle with pictures.

Figure 2: Example of dummy seat belt buckles
