Complaint - Cylinder Head Cover Near the Injector Holes Leaking: Subsequent Work on Cylinder Head (180/18)

Vehicle Type: **Panamera (971) / Panamera 4 (971) / Panamera 4 Sport Turismo (971) / Panamera 4S (971) / Panamera 4S Sport Turismo (971) / Panamera 4 E-Hybrid (971) / Panamera 4 E-Hybrid Sport Turismo (971) / Panamera 4S E-Hybrid (971) / Panamera 4S E-Hybrid Sport Turismo (971)**

Concerns: **Cylinder head cover**

Cause: **Complaint about injector hole leaks**

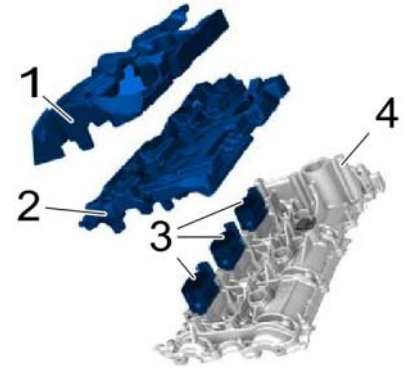
Cylinder head cover component overview

- 1 – Insulation on top of cylinder head cover
- 2 – Insulation on bottom of cylinder head cover
- 3 – Solenoid hydraulic valve for valve lift adjustment
- 4 – Cylinder head cover

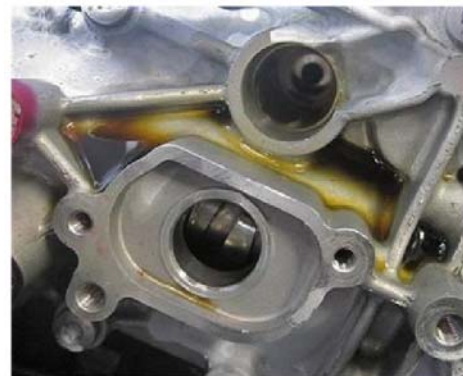
- 2.2 Remove insulation on bottom of the cylinder head cover.
- 2.3 **Identify the affected cylinder(s) by a visual inspection:**
 - 2.3.1 Oil must have collected in the vicinity of the injector of the affected cylinder and the insulation on the bottom of the cylinder head cover should be fully soaked.
⇒ Fault type 2: Cylinder head cover leaking

Fault type 2: Cylinder head cover leaking
