Technical Service Bulletin

Subject: SQUEAKING OR RUBBING NOISE WHEN OPENING/CLOSING FRONT DOOR	Bulletin No.: 09-022/23
	Last Issued : 07/26/2023

2024 CX-90

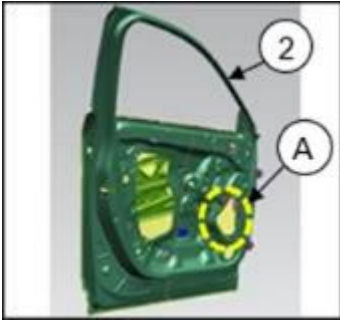
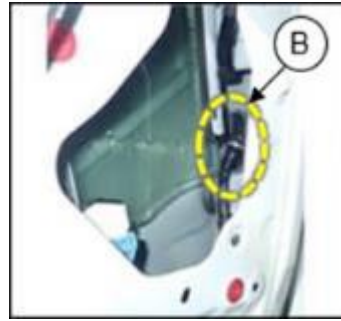
DETAIL OF A

The harness interferes with the bottom edge of the door harness grommet.

4. Apply the non-woven fabric(s)(1) to the front door(s)(2) according to the following images.

- Opening the front door glass (2) could facilitate the procedure. However, it can be also kept closed during the repair.
- The following image is the left side door with the window opened.
- If the fabric-applying area is wet, wipe it off before applying the fabric.
