Complaint - Cylinder Head Cover Near the Injector Holes Leaking: Subsequent Work on Cylinder Head (180/18)

Vehicle Type: **Macan S (95B) / Macan GTS (95B) / Macan Turbo (95B)**

Concerns: **Cylinder head cover**

Cause: **Complaint about injector hole leaks**

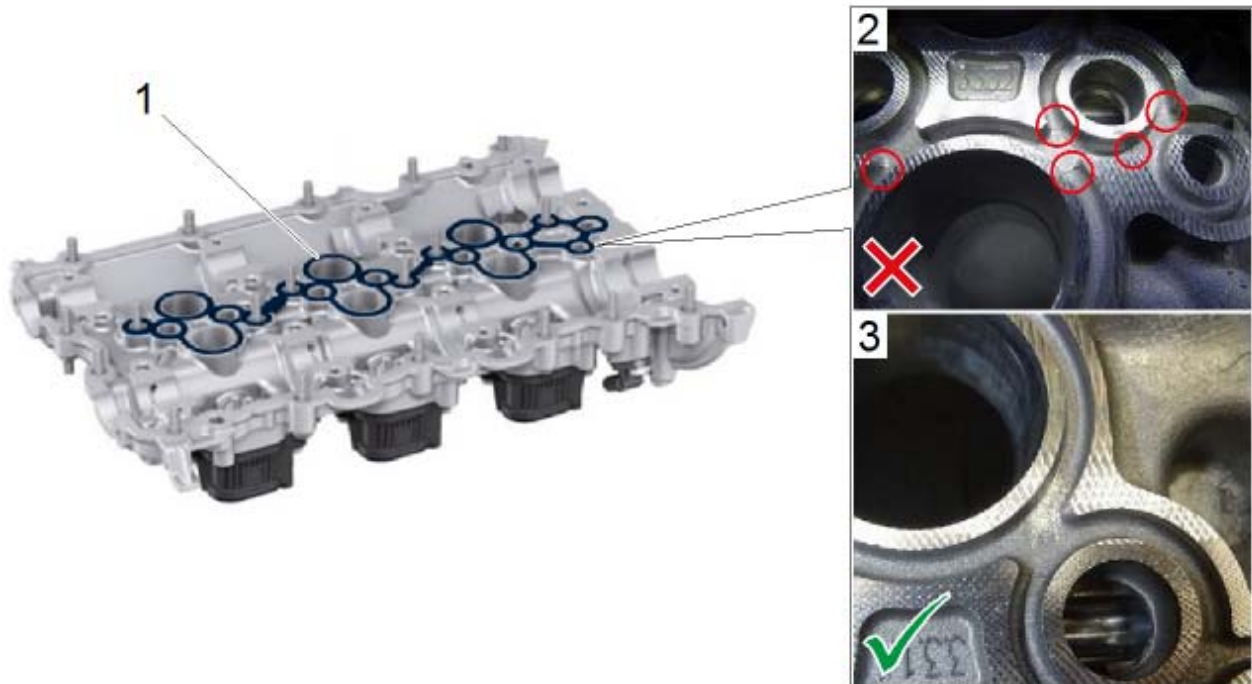
Cylinder head cover sealing groove

- Due to a batch error in the casting procedure there may be cast residue in the cylinder head cover sealing groove.
- This cast residue may be the reason for leaks in the injector holes.

2.6 Check the sealing groove (⇒ *Cylinder head cover sealing groove -1-*) of the cylinder head cover visually. Be particularly meticulous when doing this especially in the vicinity of the affected cylinder.

2.7 Carefully remove any cast residue (⇒ *Cylinder head cover sealing groove -2-*) using a small flat screwdriver, ensuring that the sealing groove is not damaged. There must be no more cast residue in the sealing groove after machining (⇒ *Cylinder head cover sealing groove -3-*).
