# Technical Service Bulletin

<b>Subject:</b>  <b>LIFTGATE SWITCH DOES NOT WORK</b>	<b>Bulletin No.: 09-028/23</b>
	<b>Last Issued : 07/07/2023</b>

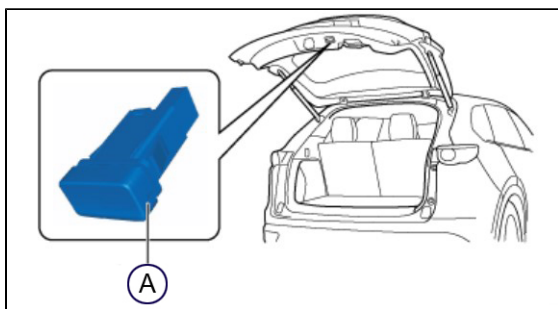
**NOTE:** CX-5 shown below

Some CX-5 and CX-30 customers may find that the liftgate does not close when pressing the power liftgate (PLG) rear switch (A) located on the interior liftgate trim. This may be caused by PLG switch corrosion. Water from a high pressure car washer and/or condensation may drip onto the switch connector and cause corrosion.

To eliminate this concern, the PLG rear switch has been modified with a waterproof connector.
