Subject: DOOR OUTER HANDLE TOUCH SENSOR DOES NOT WORK (LOCK AND/OR UNLOCK)	Bulletin No.: 09-029/23
	Last Issued : 07/10/2023

APPLICABLE MODEL(S)/VINS

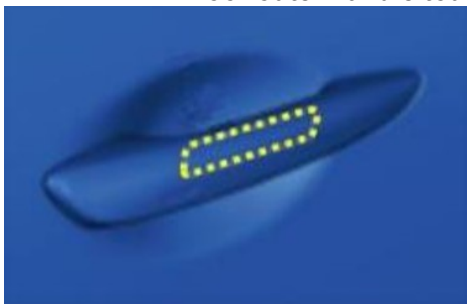
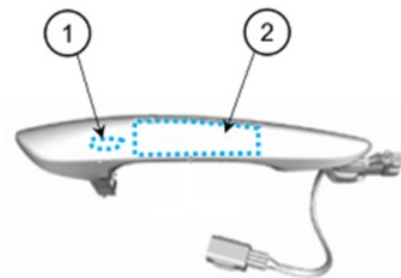
Door outer handle touch sensor for locking (1) / unlocking (2)

- Symptom 1: The touch sensor of the front door outer handle does not lock the doors after rain and/or car washing, even though unlocking is possible.
- Symptom 2: The touch sensor of the front door outer handle does not unlock the doors.

1. Verify customer concern.
2. Repair the vehicle depending on the experienced symptom(s).
 - Symptom 1 experienced: Follow the "Procedure to waterproof a touch sensor" below to make the touch sensor waterproof.
 - Symptom 2 experienced: Replace the front outer handle with a modified one according to the instructions on MGSS.
 - Mazda3 ([FRONT OUTER HANDLE REMOVAL/INSTALLATION](#))
 - CX-30 ([FRONT OUTER HANDLE REMOVAL/INSTALLATION](#))
 - MX-30 ([FRONT OUTER HANDLE REMOVAL/INSTALLATION](#))
 - Both Symptoms experienced: Replace the front outer handle with a modified one and follow the "Procedure to waterproof a touch sensor" below to make the touch sensor waterproof.

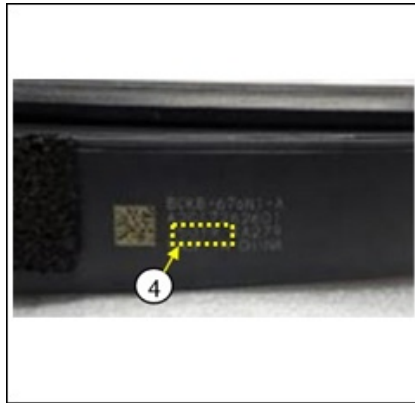
(4) (Detail of (3)) The serial number is in NNNYY format (N NN: day of year, YY: year).

- If the serial number on the front outer handle is "072 20" (72th day of 2020) or later, it is a modified part.
