Service Alert

Mazda North American Operations
Irvine, CA 92618-2922

Subject: CONNECTED VEHICLE SYMPTOM TROUBLESHOOTING	Service Alert No.: SA-009/23
	Last Issued : 07/05/2023

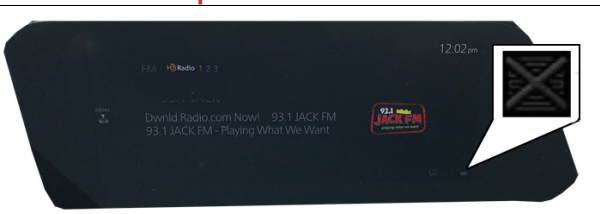
Infotainment Center Display	<ul style="list-style-type: none"> • TCU in Deactivation Mode • One Time Passcode (OTP) is processing 	<p>Reception Icon Shows "X"</p>

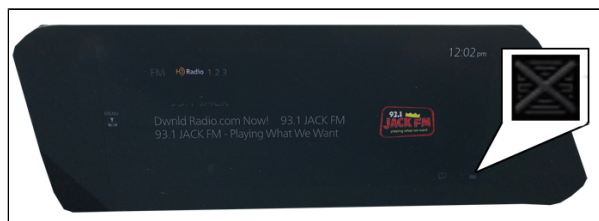
- If the reception icon shows "X", the vehicle is possibly in Deactivation Mode.

- Customer/Dealer can activate CV services anytime via MyMazda app (there just might be a slight delay in making the backend connection since it was temporarily deactivated).
- If the reception is weak, move the vehicle to a location where the reception is good to strong as shown in the table, then try to get the Authorization Code and/or operate the remote functions before proceeding to the Repair Procedure if there is still an issue.
- If the reception is good to strong, proceed to Connected Vehicle Troubleshooting below.

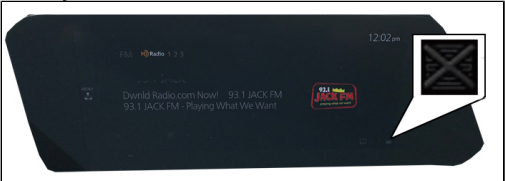
Engine started with key transmitter instead of MyMazda App.	Advise customer they will see an error message when attempting to make a Remote Engine Off request if they initially turned on vehicle with a physical key (instead of through their MyMazda app).
3	No One Time Passcode (OTP) (Vehicle infotainment center display does not provide the Authorization Code during the MyMazda App enrollment)	<p>Deactivation Mode</p> <p>1. Check the reception level strength on the mobile device and vehicle. If weak, move to a location with good strength and retry. 2. If the vehicle reception strength icon shows "X", the vehicle may be in Deactivation Mode.</p>

<ul style="list-style-type: none"> • Wait 30 minutes to an hour until the reception icon shows normal reception.
