Subject: CENTER CONSOLE OFF CENTER OR RUBS ON DRIVER SEAT WHEN MOVING SEAT	Service Alert No.: SA-040/23
	Last Issued : 07/14/2023

2021-2024 CX-5

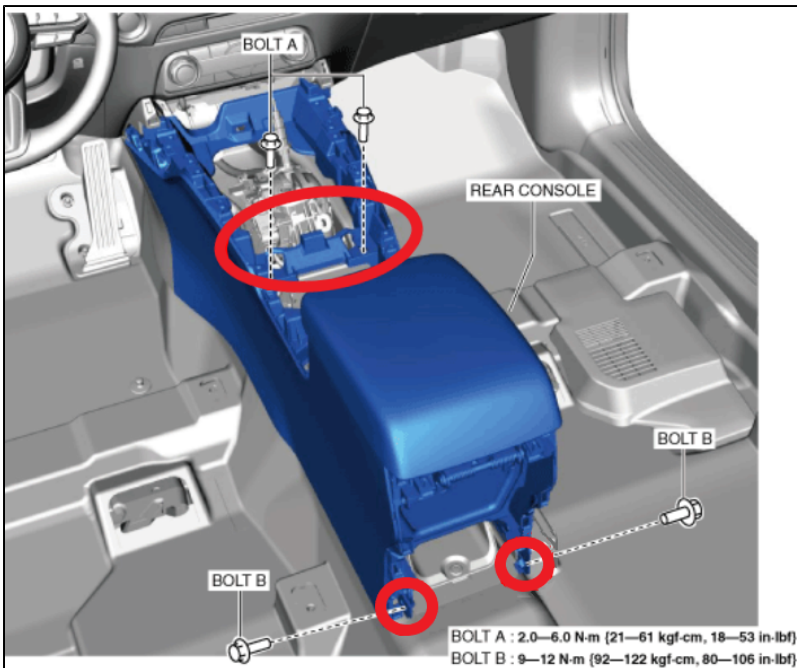
Some customers may experience a squeak noise by the center console, this is caused by the center console rubbing on the seat.

4. Remove "B" bolts.
5. Loosen "A" bolts.
6. Adjust the center console so it is centered between the seats and hold that position while "A" bolts are tightened.
NOTE: If the center console shifts off-center after the "A" bolts are tight, perform step 3 again, but hold the center console just a bit past the center point so it will spring back to the center.
7. Reinstall "B" bolts.
8. Recheck the center console fitment.
NOTE: If it is off-center, repeat the repair from step 1 but hold the center console a bit past center when tightening the bolts.
9. Verify the repair.
