Service Alert

Subject: MELTED OR WARPED MIRROR COVER OR OUTSIDE TRIM	Service Alert No.: SA-039/23
	Last Issued : 07/06/2023

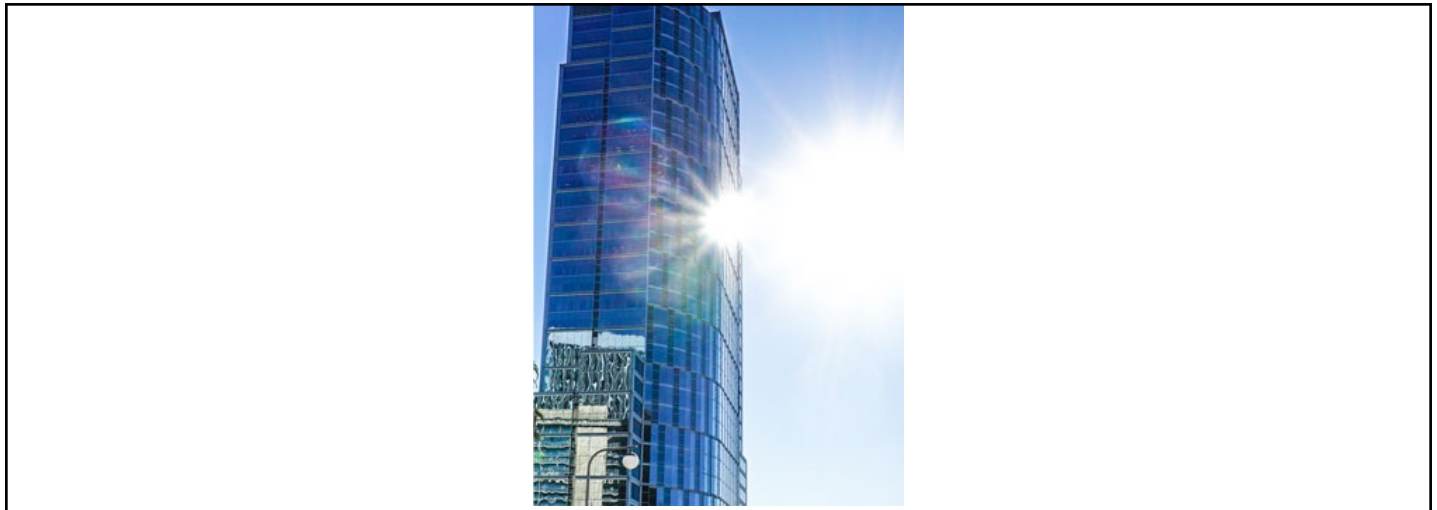
Some vehicles may experience exterior trim heat damage when parked near a glass building or Low-E windows. This may be caused by the sun's reflection.
