SIB 62 01 23 TFT SOFTWARE UPDATE

2023-06-07

SERVICE ACTION: TFT SOFTWARE UPDATE

**BMW
MOTORRAD**

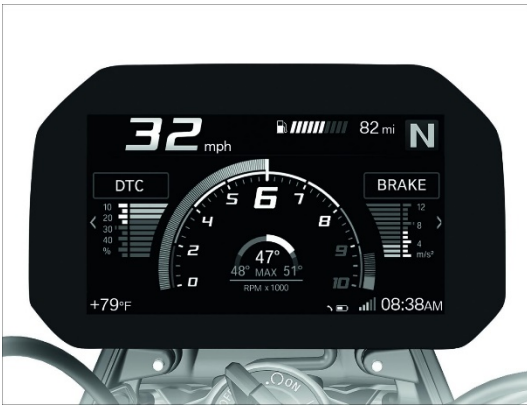
Overview of "Sport" view

With the second model update of the R 1250 R and R 1250 RS, the "Sport" view in the TFT display is part of the standard equipment. This sub-function is not activated in vehicles that are not equipped with optional equipment "224 Drive modes Pro".

The "Sport" view can be activated with a vehicle software update to I-level K001-23-07-500 in the TFT display (available with ISTA programming version 4.41.30 (ISTA version 4.41.41), Released on June 7th 2023

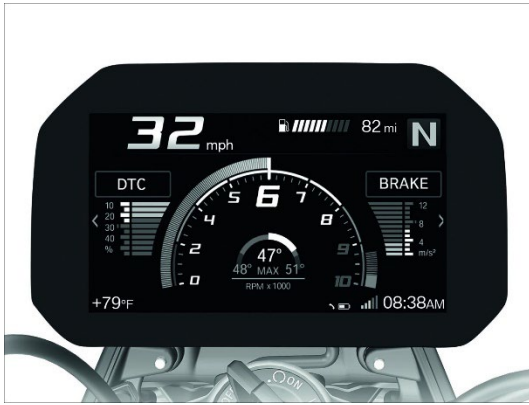
Overview of “Sport” view

With the second model update of the R 1250 R and R 1250 RS, the "Sport" view in the TFT display is part of the standard equipment. This subfunction is not activated in vehicles that are not equipped with optional equipment "224 Drive modes Pro".

The "Sport" view can be activated with a vehicle software update to I-level K001-23-07-500 in the TFT display (available with ISTA programming version 4.41.30 (ISTA version 4.41.41), Released on June 7th 2023
