SIB 11 14 21

**SERVICE ACTION: CHECK ROCKER ARMS AND REPLACE WHERE NEEDED**

2023-06-05

This Service Information Bulletin replaces SIB 11 14 21 **dated November 17<sup>th</sup>, 2021**.

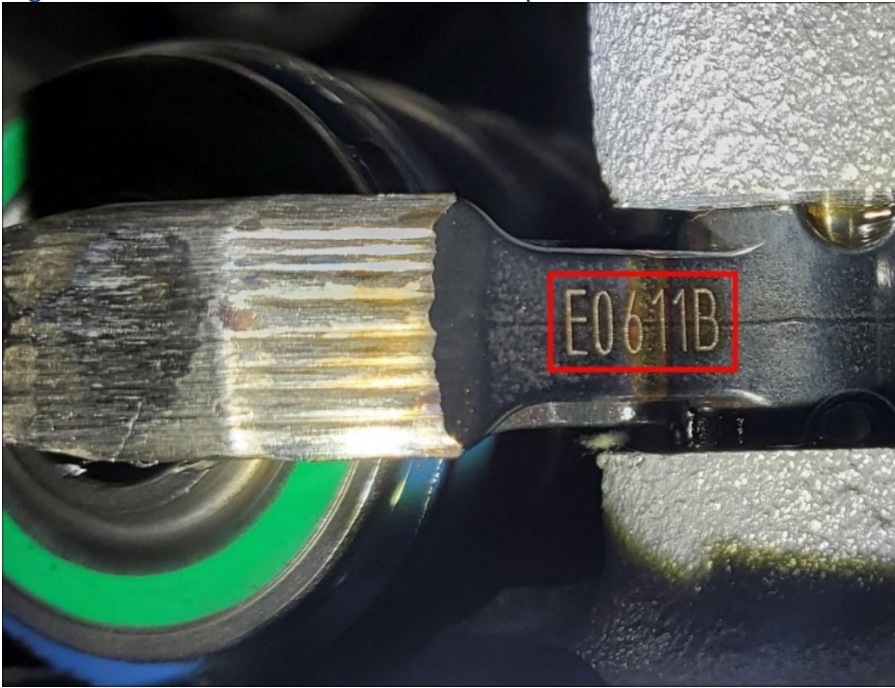
Due to a process deviation during production, the surface coating of the rocker arms may wear prematurely. Over time, increased wear on the rocker arms may also result in premature wear of the camshafts.

Figure 1: Worn rocker arm, shown with production batch number:

When at least one rocker arm with production batch E0611A or E0611B is found and black surface coating shows wear on at least one of these rocker arms, **all rocker arms and both camshafts must be replaced.**

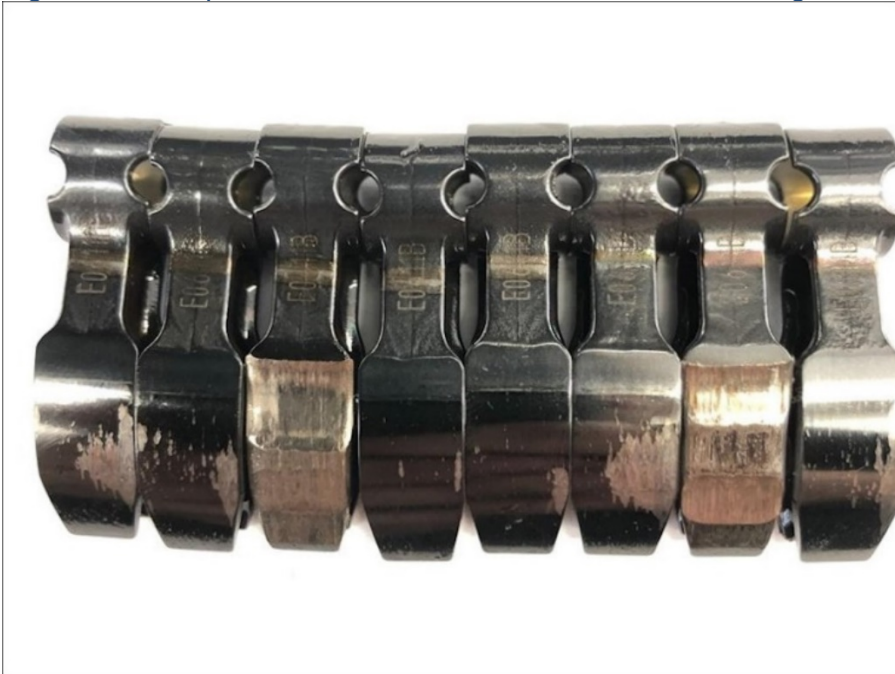
Figure 2: Examples of rocker arms with worn surface coating:

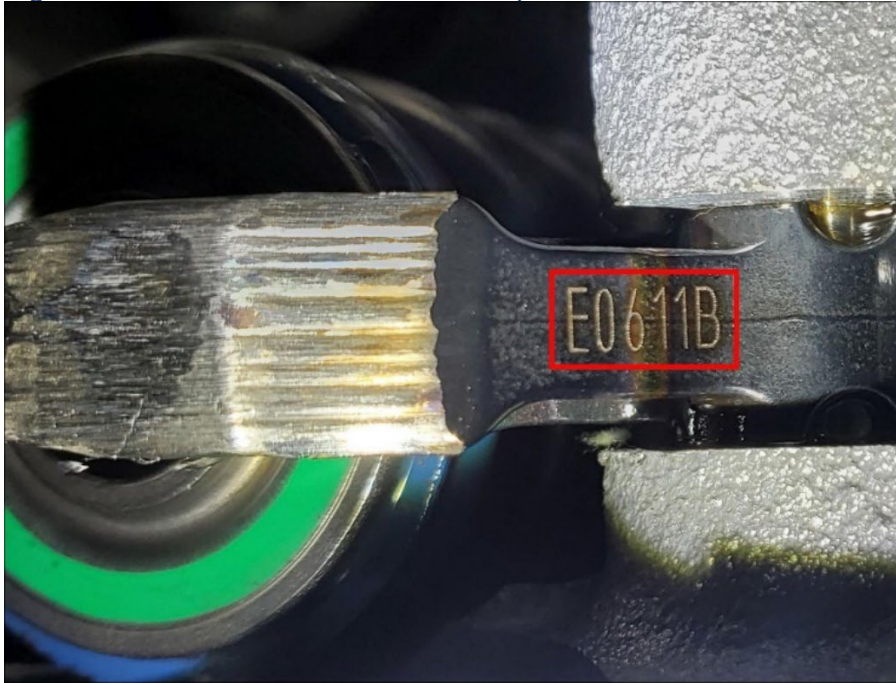
Due to a process deviation during production, the surface coating of the rocker arms may wear prematurely. Over time, increased wear on the rocker arms may also result in premature wear of the camshafts.

Figure 1: Worn rocker arm, shown with production batch number:

When at least one rocker arm with production batch E0611A or E0611B is found and black surface coating shows wear on at least one of these rocker arms, **all rocker arms and both camshafts must be replaced.**

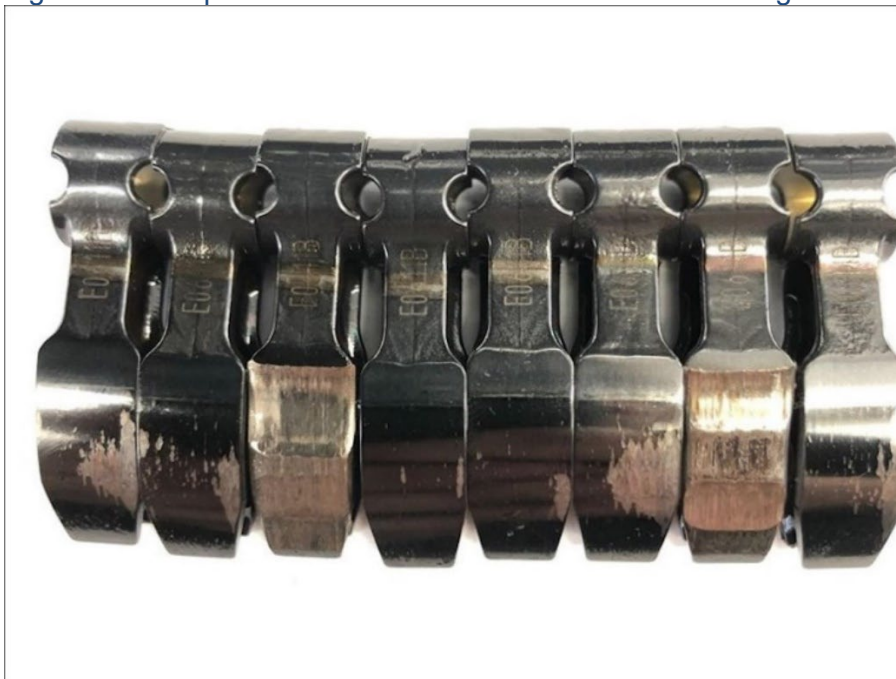
Figure 2: Examples of rocker arms with worn surface coating:
