# TECHNICAL SERVICE BULLETIN

Classification: EL22-011B	Reference: NTB22-051B	Date: July 11, 2023
------------------------------	--------------------------	------------------------

## HORN INOPERATIVE

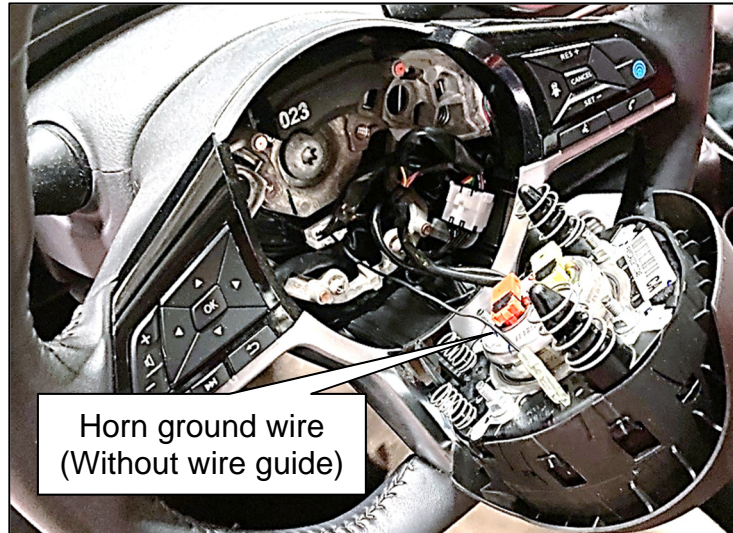
Figure 7

9. Inspect the horn ground wire for signs of pinching.
- If signs of a pinched ground wire are present, proceed to step 10 on page 7 to replace the high and low horns.
  - If signs of a pinched ground wire are not present, skip to step 11 on page 7 to install the driver airbag module.

10. Replace the high and low horns.
  - Refer to the ESM: **DRIVER CONTROLS > HORN > REMOVAL AND INSTALLATION – HORN: Removal and Installation**

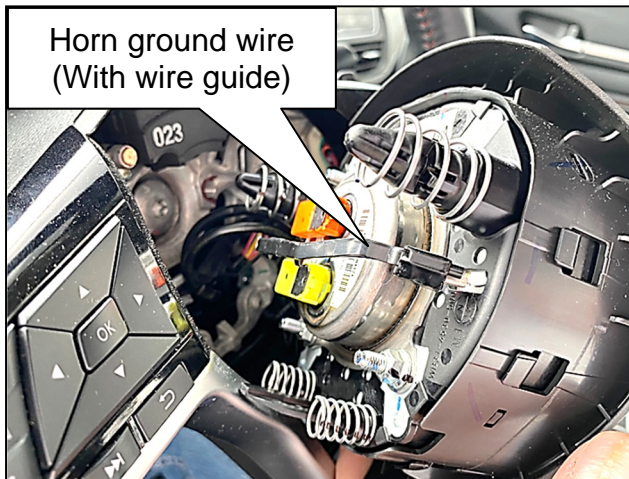
**HINT:** Some 2023 vehicles have a rigid plastic wire to guide the horn ground wire (Figure 8 and Figure 9). This guide acts to help control the horn ground wire and prevent a pinched condition. However, pinching of the horn ground wire is still possible if the guide has been bent out of position.

- The pinched ground wire does not require a wire repair.
  - If the vehicle does not have the wire guide:
    - When installing the driver airbag module to the steering wheel, rotate the driver airbag module clockwise 360° to remove excess slack from the ground wire and to prevent the ground wire from becoming pinched.
  - If the vehicle does have the wire guide:
    - DO NOT rotate the driver airbag module prior to installing. Ensure the connector has adequate retention to the spade terminal, and reposition the wire guide to the proper position by adjusting the angle of the spade terminal (if necessary). The guide should be between the orange and yellow airbag connectors and parallel to the surface of the airbag inflator, as shown in Figure 8 and Figure 9 on page 6.
