GLOBAL SAFETY FIELD INVESTIGATIONS  
DCS6639  
URGENT - DISTRIBUTE IMMEDIATELY

Subject: N232411300 - Service Update  
Brake Fluid Leak

Models: 2023 Chevrolet Silverado 4500 HD/5500 HD/6500 HD

## N232411300 Brake Fluid Leak

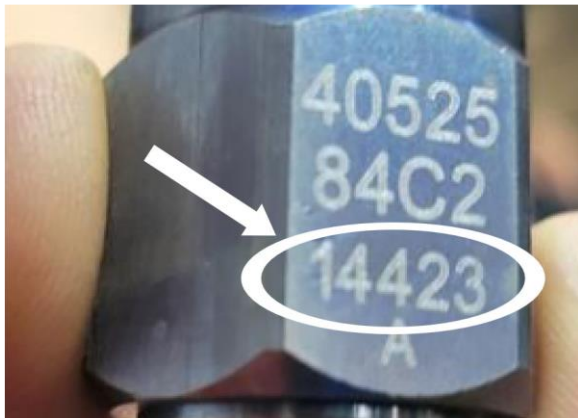
6396347

7. Using a mirror if necessary, inspect brake master cylinder pressure sensor for Lot Code: **04523** (*Lot Code location shown above*).
  - If Lot Code does not match **04523**, no further action is required.
  - If Lot Code is **04523**, proceed to step 8.

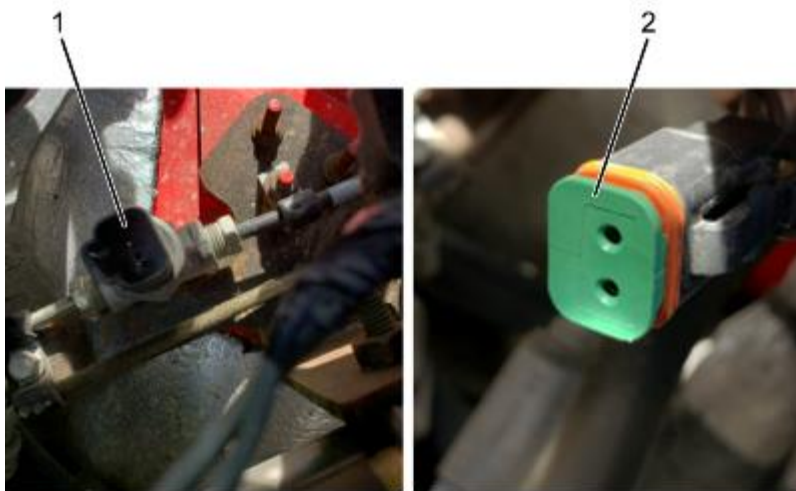
6361847

9. Inspect for presence of brake fluid at both the Brake Pressure Switch Terminals (1) and Harness Connector (2).
- If there is NO brake fluid in the switch terminals or harness connector, proceed to step 10.
  - If there is brake fluid present in the switch terminals or harness connector, proceed to step 13.

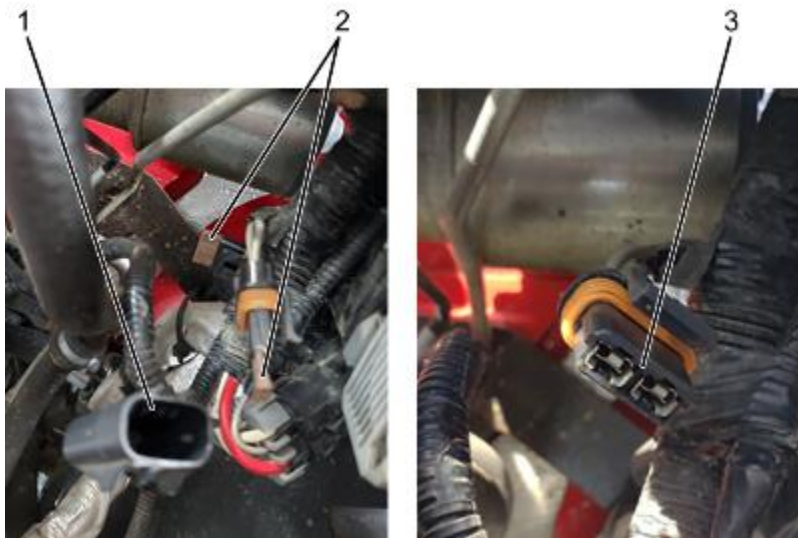
6361850

10. Locate both 5-amp fuses (2) and remove the protective cover (1).
11. Remove the fuses (2).
12. Inspect for presence of brake fluid in both fuse connections (3).
  - If brake fluid is NOT present in the fuse connectors, reinstall fuses and protective covers. Proceed to step 13.
  - If brake fluid is present in either fuse connectors, it is NOT necessary to reinstall fuses and protective covers, proceed to step 13.
