Technical product information

Topic	HVAC not working – No air flow - DTC B10AE31 High Pressure sensor - No signal DTC logged within address 08
Market area	Australia E04 Bentley rest Asia and Australia (6E04),China 796 VW Import Comp. Ltd (Vico), Beijing (6796),Germany E02 Bentley rest Europe (6E02),Japan E03 Bentley Japan (6E03),Korea, (South) E08 Bentley South Korea (6E08),United Arab Emirates E06 Bentley Middle East and Africa (6E06),United Kingdom E01 Bentley UK (6E01),United States E05 Bentley USA and rest America (6E05)
Brand	Bentley
Transaction No.	2067429/3
Level	EH
Status	Approval
Release date

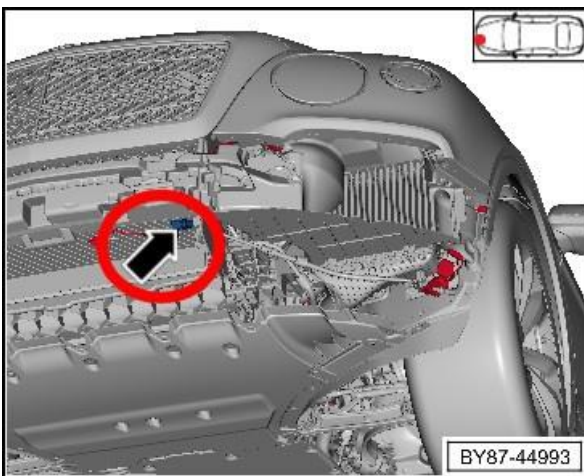
Figure 1

- HVAC not working to specification (No air flow)
- DTC B10AE31 High Pressure sensor - No signal DTC logged within address 08

- 1) Referring to the applicable wiring diagram - Conduct a wiring integrity check for sensor G65 and associated circuits TIP: Should the wiring integrity check be to specification the operative should conduct the remaining steps to completion
- 2) Referring to Rep.Gr 87 - Discharge the refrigeration system
 - Gain access to High pressure sensor G65 (Figure 1)

- Replace G65 and associated parts (See parts information section)
 - Refit all previously removed components
 - Referring to Rep.Gr 87 - Charge the refrigeration system
- 3) Check/confirm the HVAC system is working to specification as follows:
