TECHNICAL SERVICE BULLETIN

2.5L FHEV - 4WD - Grinding/Rubbing Noise While Braking At Or Below 10 MPH (16 Km/h) From The Front Of The Vehicle

23-2244

Ford 2020-2023 Escape	Engine: 2.5L FHEV 4WD
---------------------------------	--------------------------

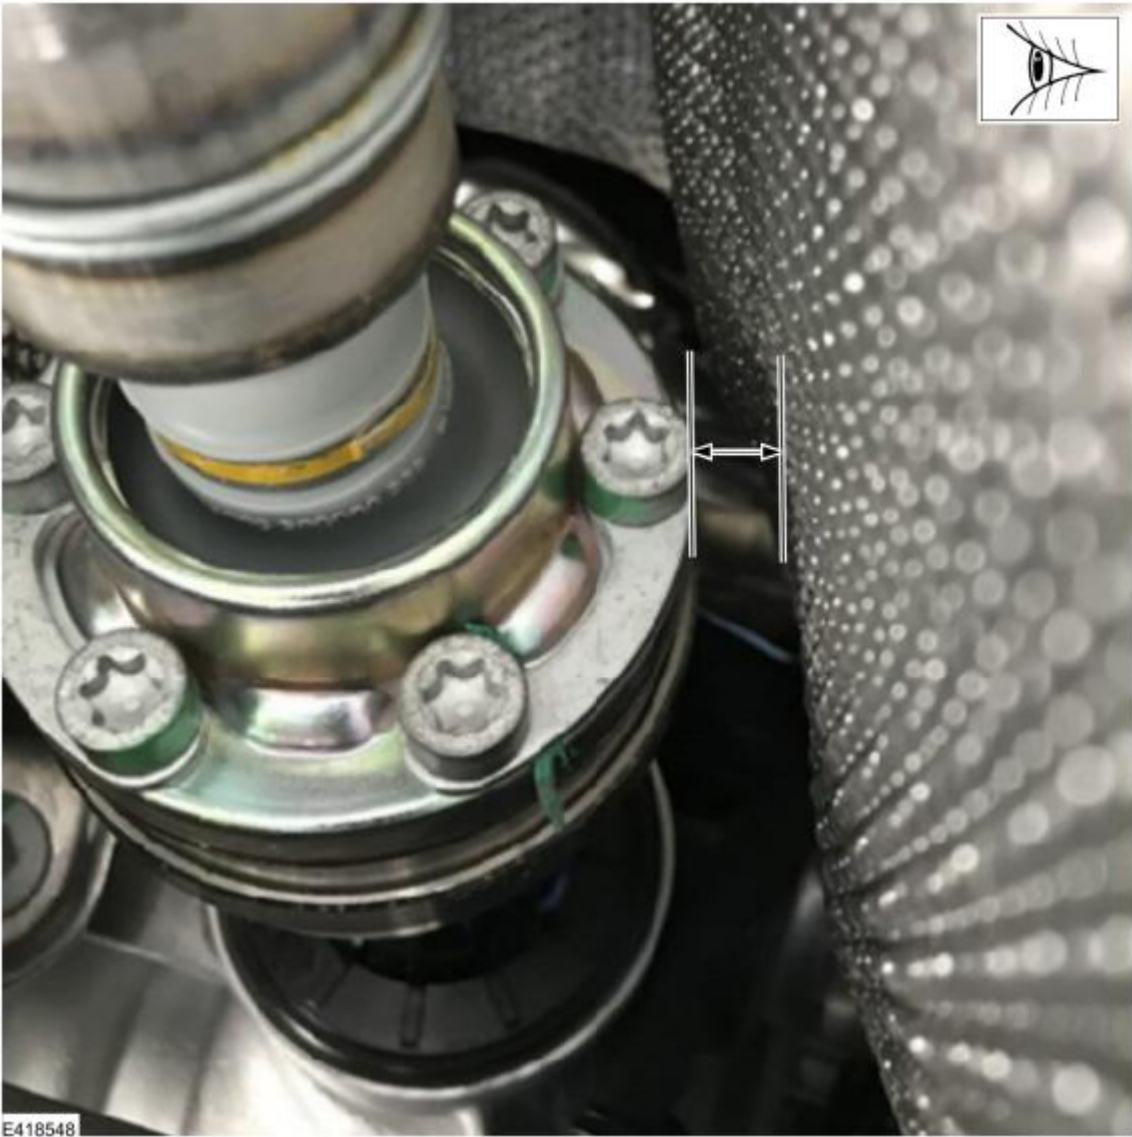
Issue: Some 2020-2023 Escape hybrid vehicles equipped with a 2.5L full hybrid electric vehicle (FHEV) powertrain and 4-wheel drive (4WD) may exhibit a grinding or rubbing noise while braking at or below 10 mph (16 km/h) from the front of the vehicle. This may be due to an inadequate gap between the driveshaft and the heat shield. To correct this condition, follow the Service Procedure to diagnose and position the heat shield away from the driveshaft.

Figure 1 - Example of inadequate gap between the driveshaft and the heat shield

4. If the gap is below 25.4 mm (1 inch) or if there are any rubbing marks between the driveshaft and the fasteners, position the heat shield away from the driveshaft. (Figure 3)

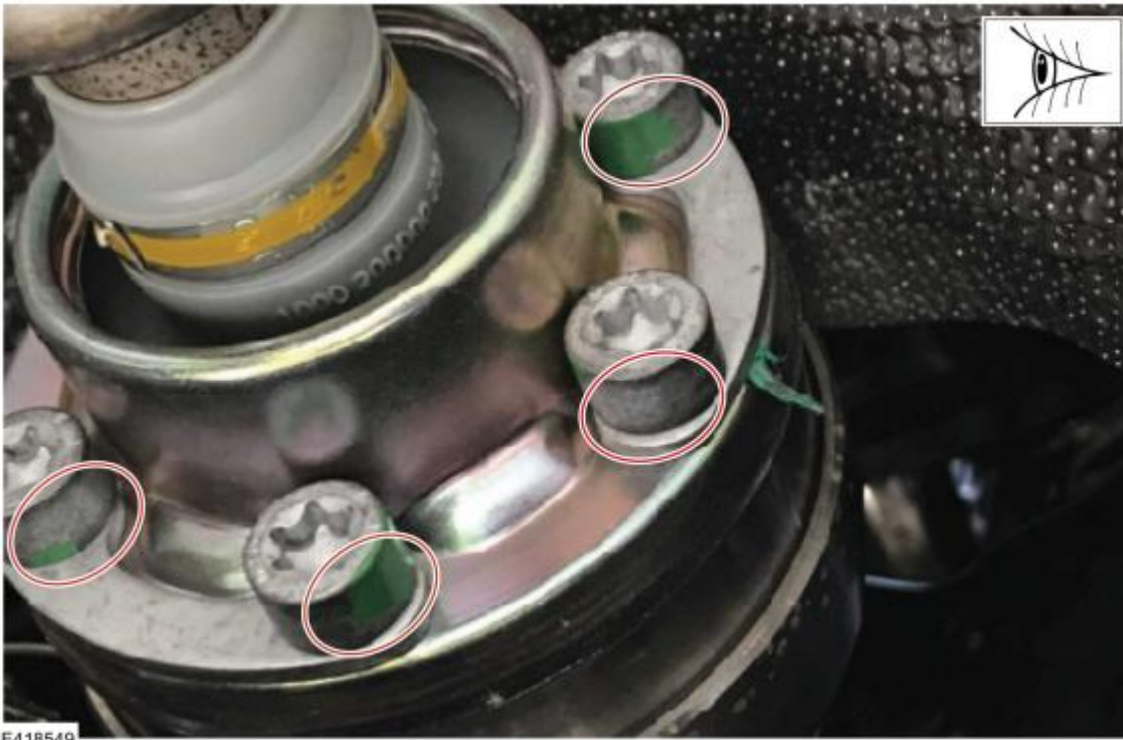
Figure 2 - Example of rubbing marks on the driveshaft fasteners
