INSTRUMENT CLUSTER SOFTWARE UPDATE

AFFECTED MODELS:
2023 890 ADVENTURE
2023 890 ADVENTURE R

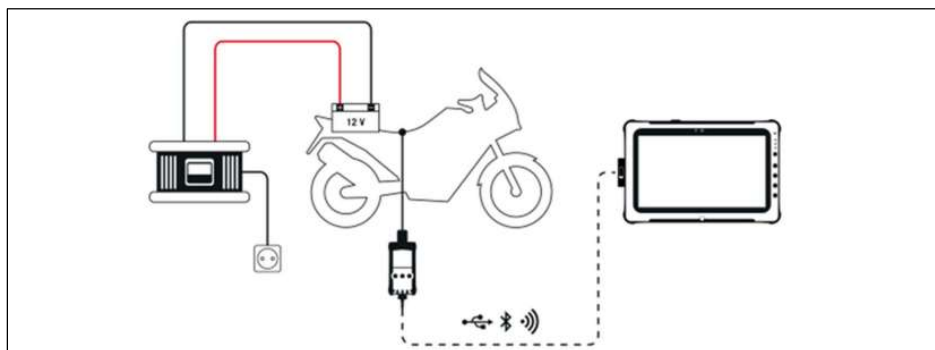
In the course of continuous product improvement and further development, the instrument cluster software has been optimized. After switching the ignition off and on, the previously set Ride Mode is retained. KTM instructs to update the software of the instrument cluster on motorcycles that are linked to this bulletin by VIN in KTM Dealer.net.

1. Connect the motorcycle to the diagnostics tool and external power supply (XCharge) as shown in the XC_2 diagram.
2. Switch off the emergency OFF switch.
3. Select instrument cluster and update to **DAKTA61005000550.encs19** or newer software.
4. After successfully updating, switch off the ignition system for at least 1 min.
5. Switch on the ignition system.
6. Select control unit diagnostics and run AutoScan.
7. Check the control unit for any possible errors and correct model variant.
8. Correct the model variant if necessary.
9. Clear any trouble codes.
