GROUP	MODEL
Product Improvement	2022-2024MY Carnival (KA4) Non-SX-Prestige
NUMBER	DATE
PI2301	August 2023

INSTALLATION OF STEEL REINFORCEMENT PLATES FOR 2ND ROW SEAT OUTER RAILS (PI2301)

This bulletin provides information to install steel reinforcement plates on the second-row seat outer rails in certain 2022-2024MY Carnival (KA4) LX/LXS/EX/SX vehicles (without relaxation/power seat feature) produced from January 4, 2021 through August 9, 2023. This campaign is to reinforce the mounting points of the 2nd-row seat to the floor and minimize potential seat rail detachment, should a certain rare crash event occur. Follow the procedure outlined in this publication to install the two (2) outer seat rail reinforcement plates on the applicable vehicle. Before conducting the procedure, verify that the vehicle is included in the list of affected VINs.

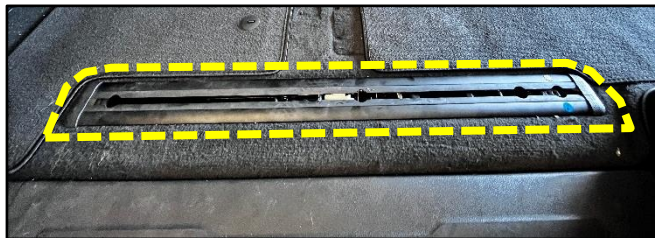
6. Insert the reinforcement plate into the seat rail as shown

Note: Ensure to correctly align the four (4) mounting holes from the reinforcement plate to the seat rail. (Left/driver side shown).

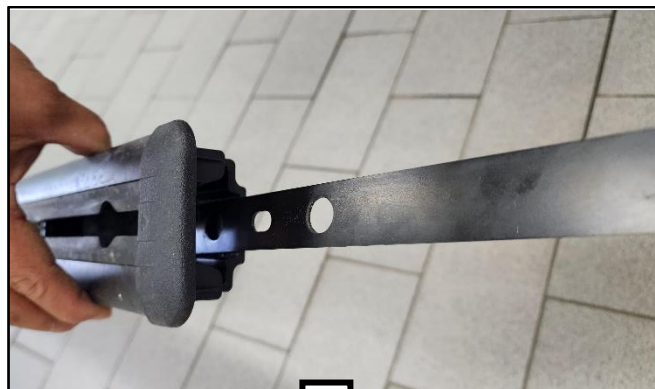
7. Re-install the outer seat rail with the inserted reinforcement plate using two (2) of the bolts removed and two (2) of the four new bolts supplied.

Note: Discard two (2) of the old bolts removed. The two (2) new bolts are to be installed in between the outer bolts, location #2 and #3 (two bolts per seat rail). The other removed 2 bolts, are to be installed in #1 and #4 location.
