| Title: | MCC HVAC Upgrades | | | |
| Number: | SB_588.4 | Release Date: | 6/20/2022 | |

## **Subject:**

Addressing fault codes and upgrades to the Midwest Climate Control (MCC) HVAC system.

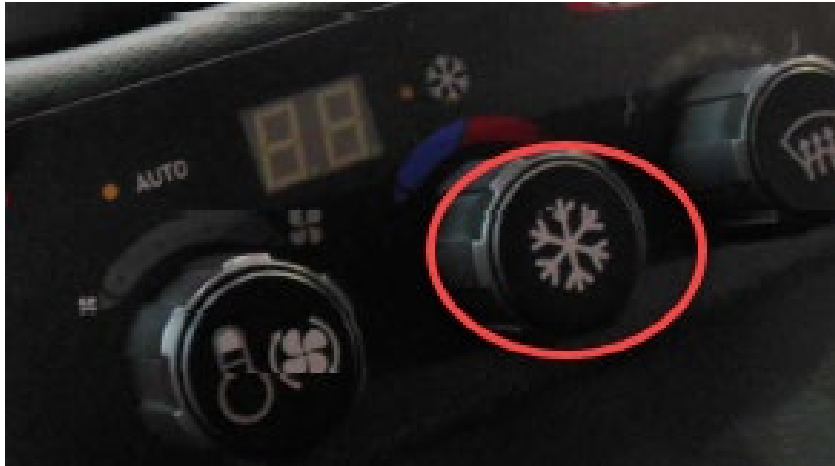
*AC Button*

6. Digital Temperature Displayed in Wrong Format

- a. Temperature can be displayed in Fahrenheit or in Celsius
  - i. To change one from the other, press the center AC button quickly 6 times and wait 10-15 seconds for it to change.
  - ii. It might be required to wait and press the AC button one more time for it to change over.
