GROUP	MODEL
CLI	2019-2023MY Forte (BDm)
NUMBER	DATE
053	August 2023

## TECHNICAL SERVICE BULLETIN

**SUBJECT: HVAC BLOWER MOTOR CONNECTOR REPLACEMENT**

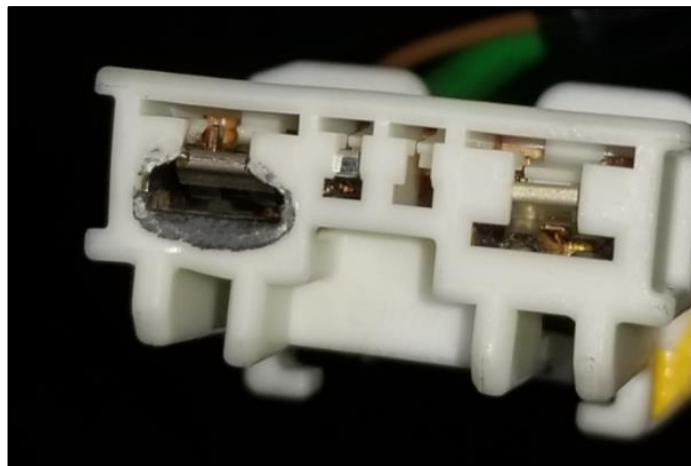
This bulletin provides information to replace the Heating, Ventilation, and Air Conditioning (HVAC) blower motor connector on some 2019-2023MY Forte (BDm) vehicles produced from July 09, 2018 through present, which may experience the air conditioning function inoperative. The blower motor connector pins may have poor pin tension. Poor pin tension occurs when the female pin is slightly open which will not allow for a proper electrical connection. While driving, the road conditions can cause the connector pin to slightly move within the connector and will intermittently contact the male pin. This may cause excessive circuit resistance, causing the blower motor to become inoperative. Follow the procedure outlined in this publication to replace the HVAC blower motor connector.
