GROUP	MODEL
ELE	2023MY Niro P/HEV, EV (SG2 P/HEV, EV) EV6 (CV)
NUMBER	DATE
300	August 2023

## TECHNICAL SERVICE BULLETIN

### SERVICE ACTION: MOOD LAMP OPERATION LOGIC IMPROVEMENT (SA536)

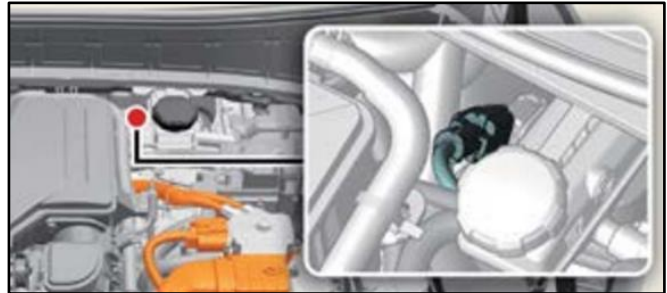
If the mood lamp is currently inoperative in Niro HEV (SG2 HEV) vehicles, disconnect the 12V auxiliary battery connector located near the brake fluid reservoir for ten (10) seconds, then reconnect the 12V auxiliary battery connector and proceed to software logic installation.
