TECHNICAL SERVICE BULLETIN

Technical Service Bulletin: 215-1668

TECHNICAL SERVICE BULLETIN 215-1668 REMEDY INSTRUCTIONS

Title: REGO Over Discharge

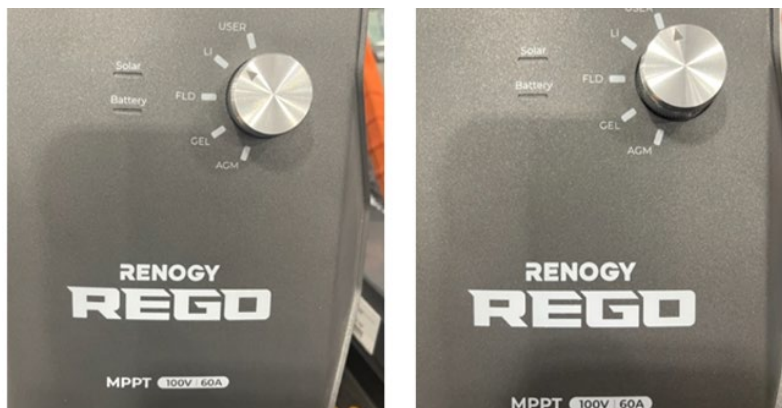
Step 2

The first issue is negative activation on the solar controller. Negative activation happens when devices or loads, such as the inverter-charger ON/OFF switch, or the House Disconnect Switch are left in the on position. This typically happens at the dealer level, as salesmen and customers will enter the unit, turning the aforementioned items on, leaving the unit in the "ON" state. Over time, the BMS activates the low voltage cut off, disconnecting the battery from use. During the day the solar panels start to conduct a positive (+) voltage and current, which the BMS uses to re-connect the battery to the system. When this happens, the loads or items that were previously left on; are energized, further discharging it to a lower level. Since the voltage will normalize, it will take some time before the BMS reads a low enough voltage to disconnect again, and when this happens; the battery will see the charge voltage once again, if present and re-active, leading to a cycle of over-discharge.

Move the battery type selector on the "MPPT" charge controller to the "USER" position. This will remove the "activation" feature from the solar controller and prevent the coach from over-discharge due to inadequate solar charge current. This is a simple solution, which can be performed by the end user or dealer technician.

Turn the programming knob to "user". See below:

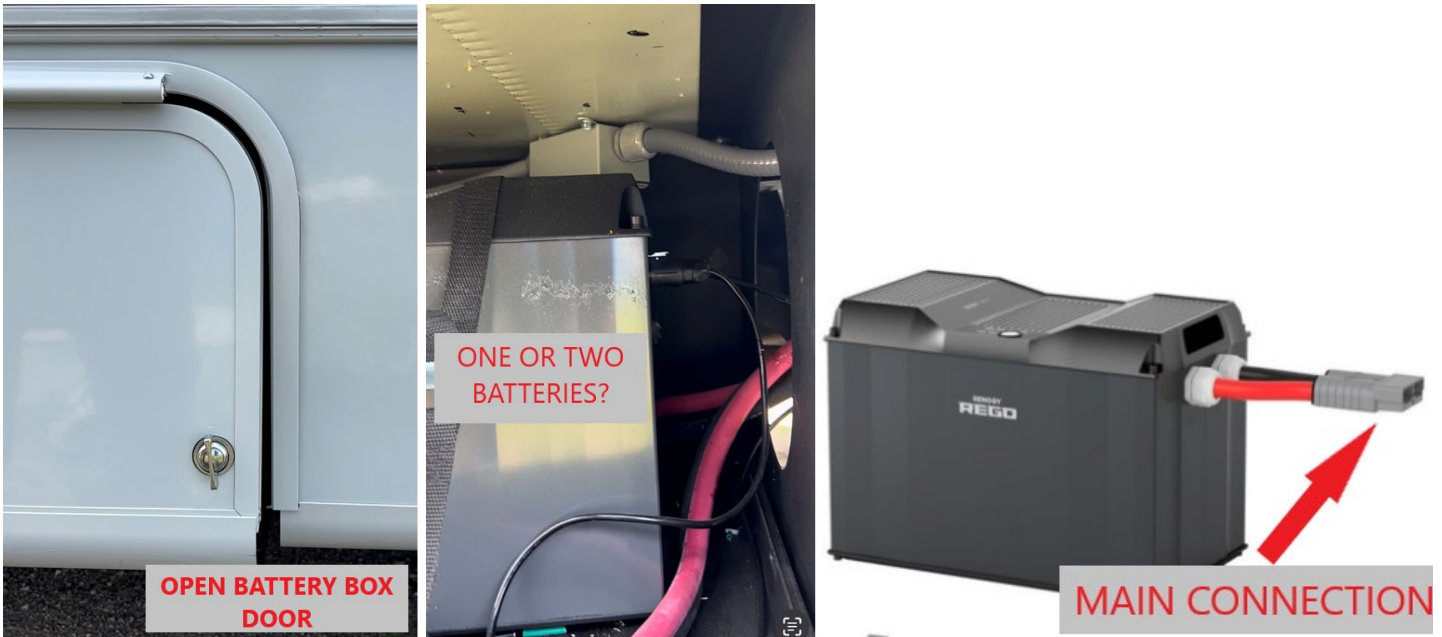
Step 1

Non-isolated ground path in the battery, a ground path via the CAN cabling. The battery has a negatively switched BMS, meaning that when the BMS interrupts the negative path of the circuit between the cells and the battery (-) terminal. Certain components can ground via the CAN PS- in the CAN cabling. This can happen when the battery shuts down in low voltage protect mode.

Open the battery box, and examine the battery(s). If there is only one battery, then 2 cables need modified, if there are two batteries, then four cables need modified. Disconnect the 4/0 gray Anderson connections, the main connections at the battery(s).
