August 11, 2023

Version 1

Panoramic Glass Roof has a Pop Noise

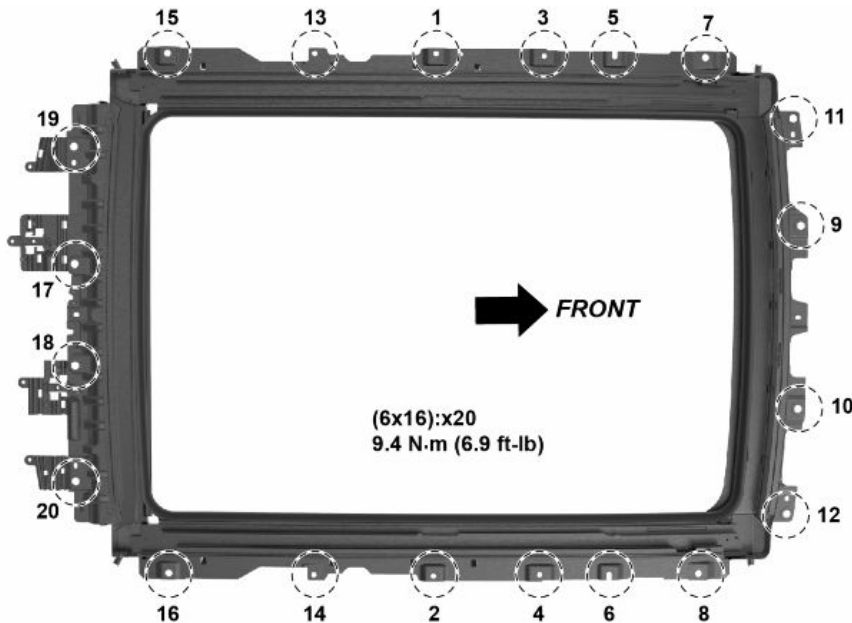
It was determined that, in some cases, the panoramic roof frame mounting bolts are unable to maintain the necessary clamp force. This can allow shifting, which may lead to a pop noise.

NOTE: Follow the Service Information procedure; search keyword **Panoramic Glass Roof** > select **Panoramic Glass Roof Mechanical Component Location Index** > select **FRAME: Removal and Installation**. After replacing the frame assembly, follow the torque pattern below. Make sure each bolt is torqued to specification **9.4 N·m (6.9 ft-lb)** during the installation process.
