Bulletin No.: PIC6511
Published date: 07/12/2023

PIC6511 Diagnostic Tip - Unwanted Park Assist Indication

Brand:	Model:	Model Years:	VIN:		Engine:	Transmissions:
			from	to		
Cadillac	Lyriq	2023 - 2024	All	All	All	All

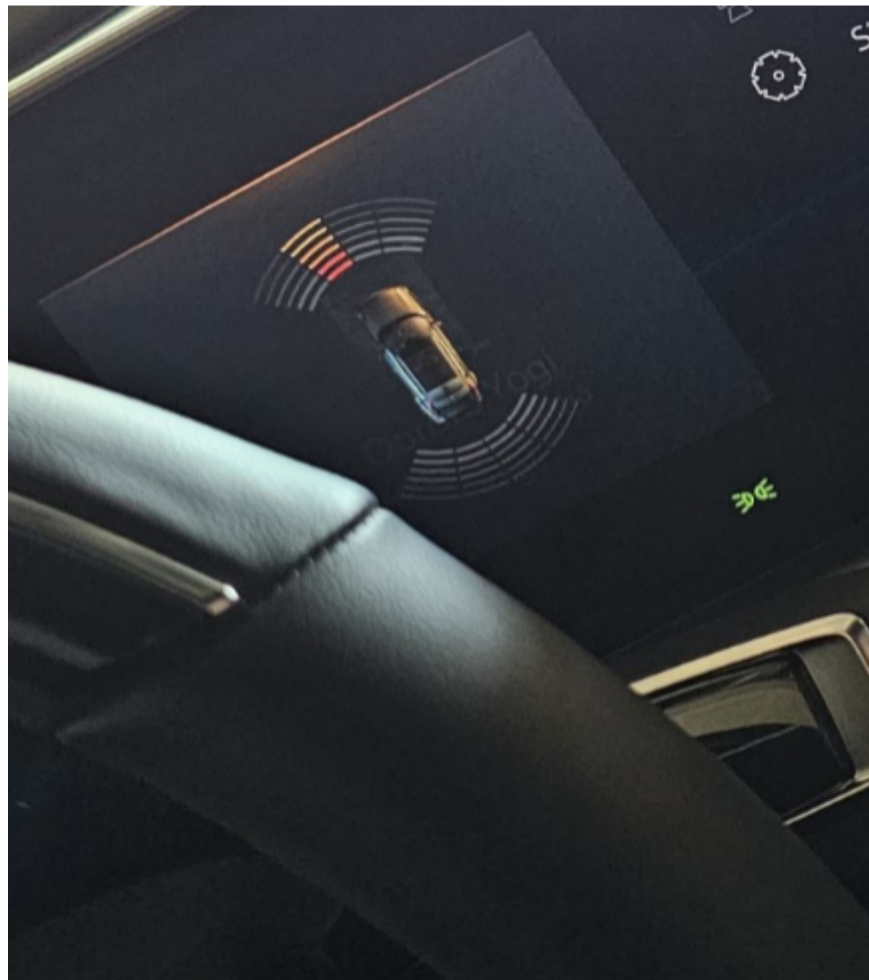
Involved Region or Country	North America
Condition	A customer may comment that the Park Assist will indicate an object detected intermittently from either the left or right front middle sensors.
Cause	Possible interference from front License Plate Frame.

Example of Park Assist indicator.
