Bulletin No.: PIT6040
Published date: 07/12/2023

PIT6040 Upfitter Aux Switch ON LED Indicators Inoperative If More Than One Switch Is On

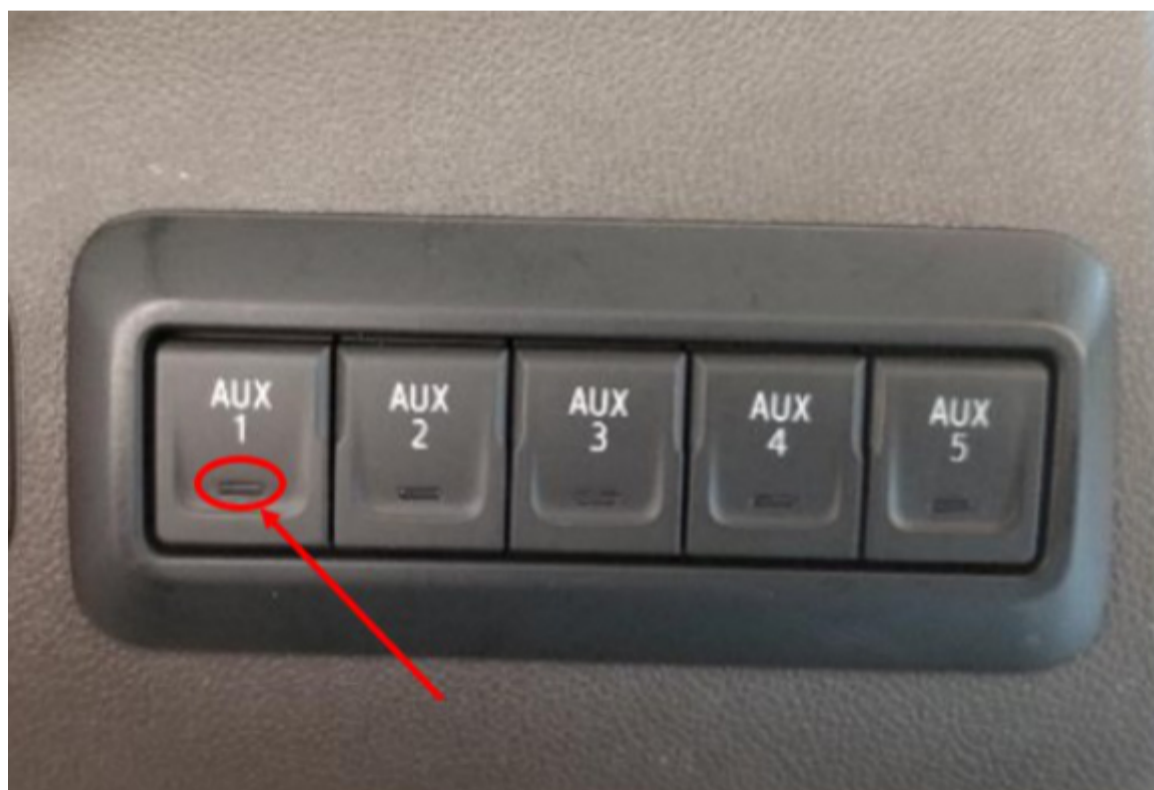
Involved Region or Country	North America
Additional Options (RPO)	9L7 Aux Upfitters Switches
Condition	Some customers may comment that the aux switch "on" indicators (shown below) do not illuminate if more than one aux switch is turned on. The aux switches do work regardless of how many switches are turned on, but the "on" indicators will go inoperative if more than one switch is turned on.
Cause	BCM calibration.

To correct this concern, reprogram the BCM with the latest calcs in TLC/SPS2.
