PIT6041 Diagnostic Tip - 3rd Row Power Folding Seat Overhead Console Switch Indicator

Brand:	Model:	Model Years:	VIN:		Engine:	Transmissions:
			from	to		
Cadillac	Escalade Models	2021 - 2023	All	All	All	All
Chevrolet	Suburban	2021 - 2023	All	All	All	All
Chevrolet	Tahoe	2021 - 2023	All	All	All	All
GMC	Yukon Models	2021 - 2023	All	All	All	All

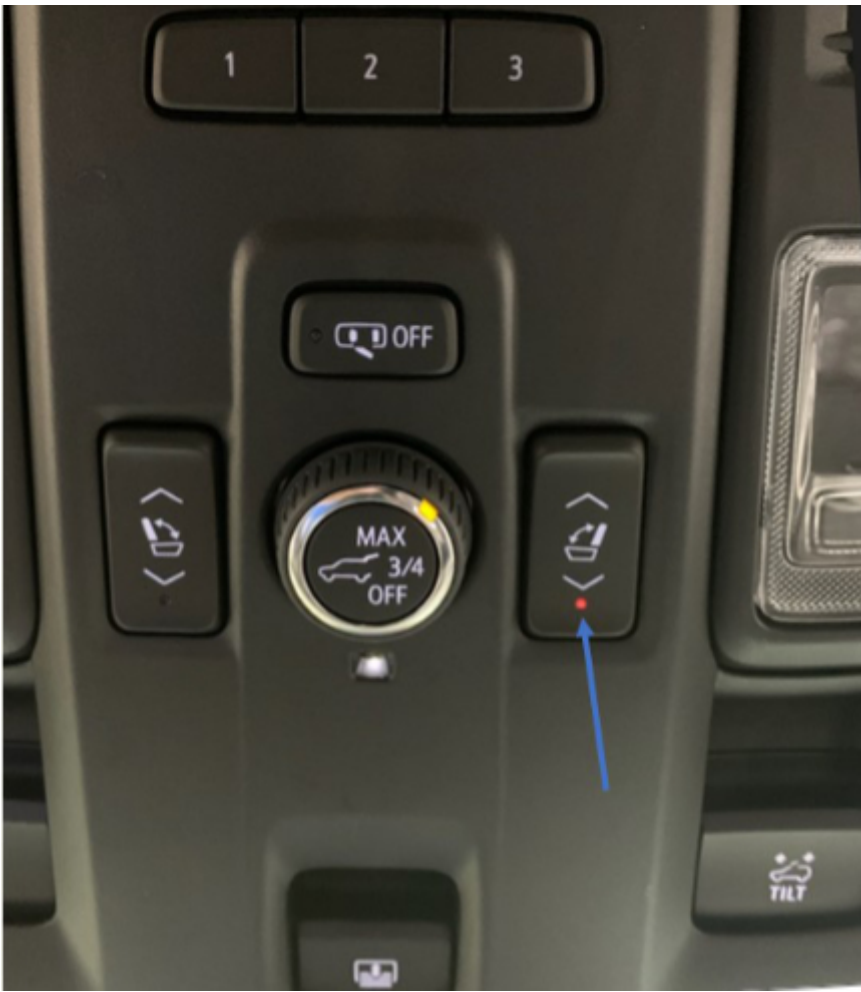
Involved Region or Country	North America
Additional Options (RPO)	AS8- Third Row Power 60/40 Split-Folding Bench Seat
Condition	Vehicles equipped with a 3rd row power 60/40 split folding bench seat may have red indicator lights that are located in the overhead console folding seat switches, shown below. These red indicators will illuminate if a third row seatback is not fully latched in the up seating position. This PI is to provide details regarding a change to the elimination of the red indicator feature. The red indicator operation/feature is being phased out and will no longer be used. Starting mid year with the 2023 models, the red indicators will no longer be used. In addition, when working on an early 2023 or previous model year, that did have operational red indicator lights, certain service parts will no longer support the feature.
Cause	Elimination of the 3rd row overhead console power folding seat switch red indicator feature.

When diagnosing a complaint of a red indicator light on in the overhead console power folding seat switch(s), if the root cause is one of the B377** Seat Back Unlatching Switches, these unlatch switches are no longer available. To correct this concern, replace only the K169 Folding 3rd Row Seat Module, which has new calibrations to ignore the B377** unlatch switches and will disable the red indicators in the overhead console switches.

Note: The B377** Seat Back Unlatching Switches were part of the 3rd row seat frame assembly, but now are eliminated. If a seat frame assembly is replaced for any reason, then the overhead console seat switch red indicators will be illuminated. In these cases, the K169 Folding 3rd Row Seat Module will also need to be replaced to disable the red indicators.
