Technical Info

FROM: Maserati TSO

Grecale - New Granturismo: air suspension system check

DATE: JULY 11, 2023

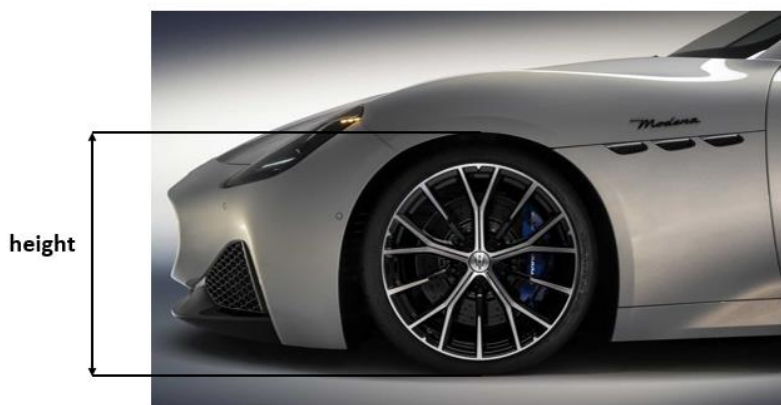
- f) disconnect the OBD tool through the window opened (doors closed)
 6. Measure the height from the ground to the highest point of each front wheel arch (Figure 1) and indicate the values in the checklist at the end of section 1. Figure 1

8. Measure the height from the ground to the highest point of each front wheel arch (Figure 1) again and indicate the values in the checklist at the end of section 1.
9. connect the EVO to the vehicle through the window opened (doors closed, don't sit in the vehicle)
10. check the pressure of the four tires from the vehicle cluster or the diagnostic tool in RFHM ECU and indicate the values in the checklist at the end of section 1 of the bulletin.
11. read the height from the ground of the highest point of each front wheel arch (height) with the diagnostic tool in VDCM ECU - 7005 - Vertical Dynamic Ride Height Sensors – and indicate the values in the checklist at the end of section 1 of the bulletin.
12. Run the "Get Out of In-Plant Mode" routine.

Compare the measures at pt.6 and pt.8 → on each corner, the difference must be smaller than **6mm**.

Compare the measures at pt.5b and pt.11 → on each corner, the difference must be smaller than **6mm**.

If the checks carried out show that the lowering of the vehicle is less than 6 mm, the vehicle can be leveled and considered compliant with the standards.

If the checks carried out show that the lowering of the vehicle is greater than 6 mm, the opening of a BOL (As support Request) is required; indicate the results of the measures carried out in the points listed above.

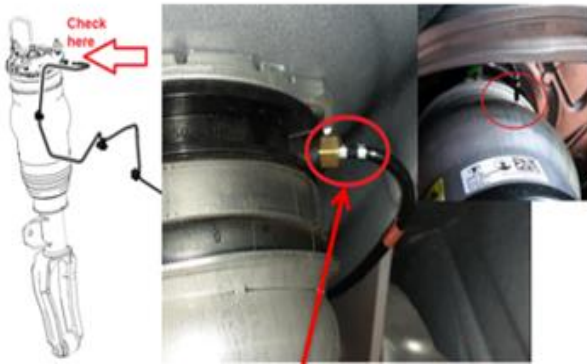
1 – Front axle

Sample of incorrect Air Suspension pipe installation on the front Air spring

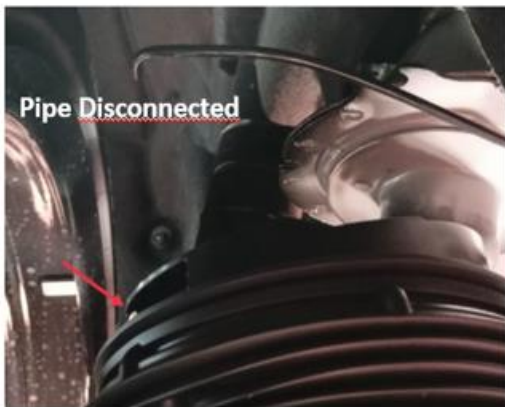
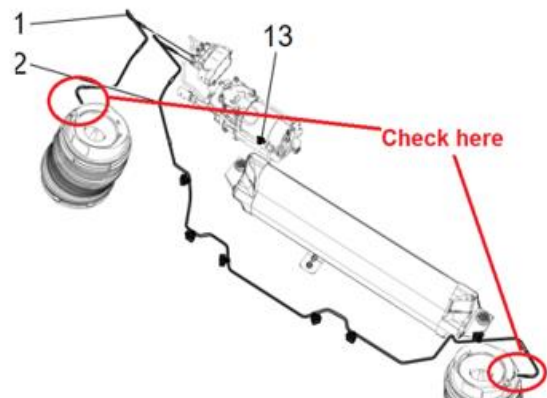
2 – Rear axle

Sample of incorrect Air Suspension pipe installation on the Rear Air Spring
