MAS003652 RU 23-29

Rapid Update 642 GranTurismo – Light Bar Bezel Replacement

DATE: JULY 12 2023

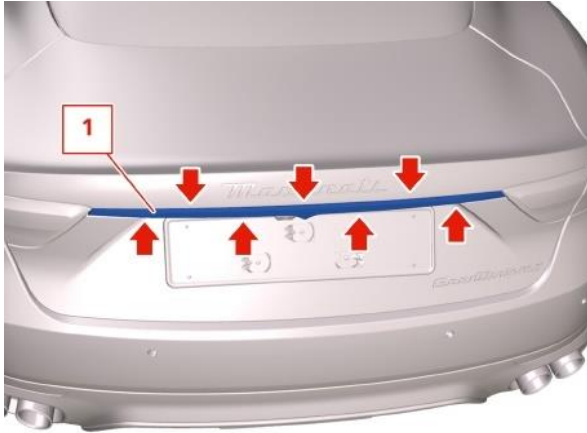
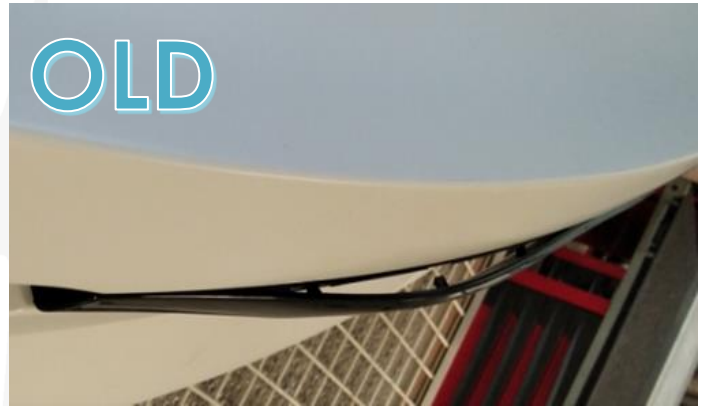
This action is needed due to the **old black-painted** moulding could be affected by detachment in case of thermal stress (heavy sun exposure, parking in hot area, etc..).

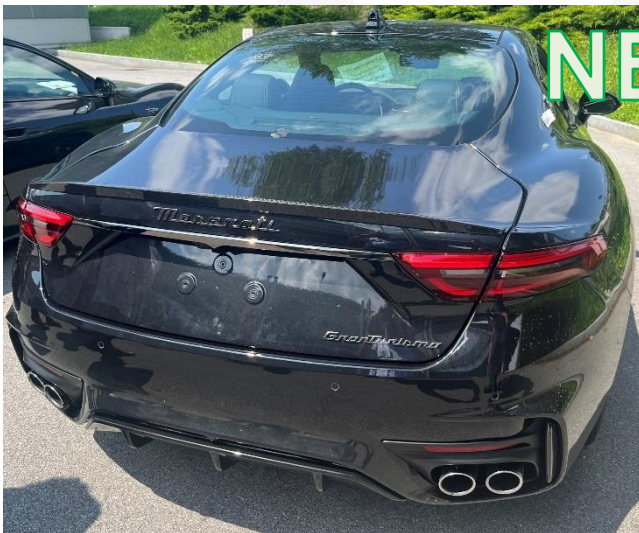
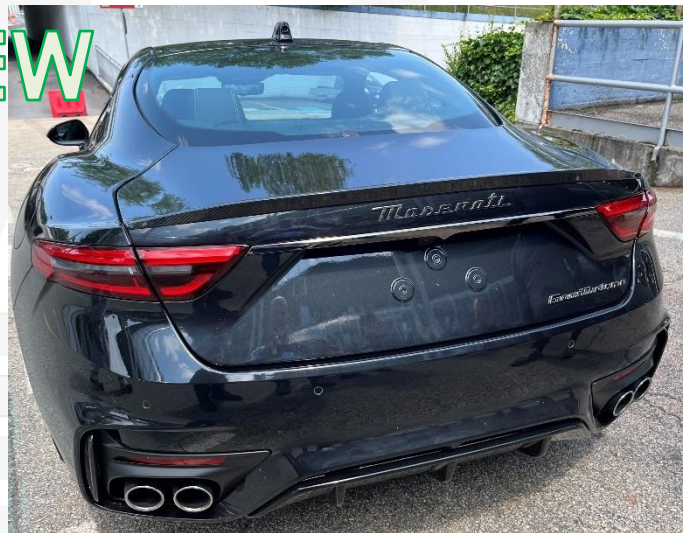
The **new** component, instead, have a **black-chrome finishing** that do not present the same defects giving a more luxury feeling to the car.

1. Always check ModisCS+ to see if the vehicle is involved in this action and if it has not been previously performed.
2. Take all the necessary precautions to avoid causing damage to the bodywork and, following the procedure in the workshop manual, proceed to replace the license plate lamp molding:
 - a. **9.15.266 - LICENSE PLATE LAMP MOULDING - Removal/refitting or replacement**
3. Refit all the parts you have removed following the removal procedure in reverse order.
4. Procedure complete.
