**RAPID UPDATE**

# Rapid Update 643 MC20 – Door gasket check

DATE: JULY 20 2023

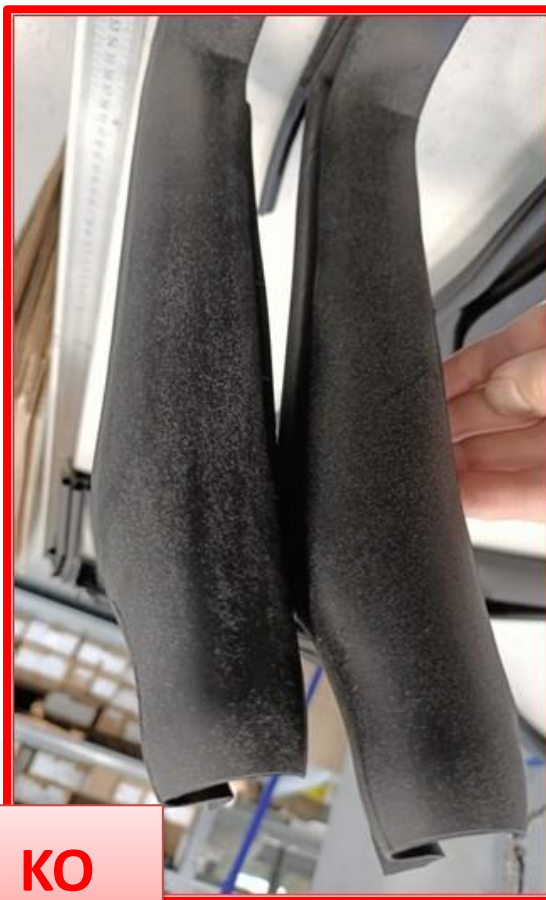
KO

In fact, due to a problem during the supplier's production process, some cars may have white spots on the seals. This is a purely aesthetic problem that does not affect the functionality of the component in any way.

This action is needed to avoid white spots phenomena on the door seats that could happens during the life of the component.

1. Always check ModisCS+ to see if the vehicle is involved in this action and if it has not been previously performed.
2. Replace the component, referring to the correct procedure in the workshop manual:
  - **9.34.096 GASKET FOR RH SIDE EDGE MOLDING - Removal-Refitting or Replacement**
  - **9.34.097 GASKET FOR LH SIDE EDGE MOLDING - Removal-Refitting or Replacement**
3. Procedure complete.
