MAS003516 RU 23-42

Rapid Update 610 Granturismo - steering column control stuck

DATE: JULY 31 2023

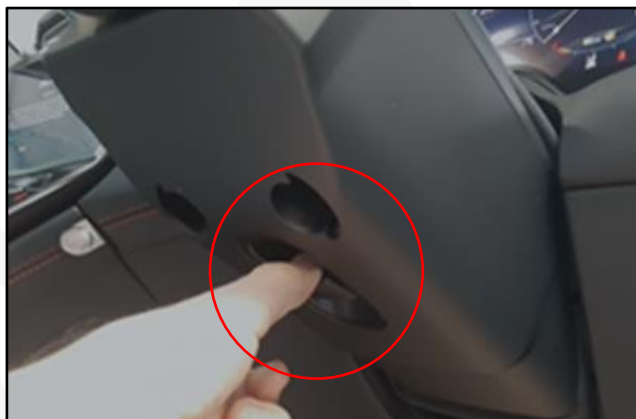
1. Always check ModisCS+ to see if the vehicle is involved in this action and if it has not been previously performed.
2. Switch the Ignition to the "ON" position.
3. Use the "power tilt/telescoping steering column/wheel switch" to operate the power tilt/telescopic steering column in the following sequence below:

- a. 3 UP activations
- b. 3 DOWN activations
- c. 3 SLIDE FORWARD activations
- d. 3 SLIDE BACK activations

For each activation and each position, please check the following conditions:

- An acoustic "click" must be audible.
- At the end of the action, the button must return to the base or resting position.
- The steering wheel movement must stop when releasing the button.

4. Switch the Ignition "OFF".
5. If all the conditions are satisfied for all the activations, the **check is OK**, no further action is needed, the procedure is complete.
6. If at least one of the conditions is not verified for one or more activations, the **check is NOT OK** and the component must be replaced, following the procedure below (available in the workshop manual):
 - **8.50.055.0 - STEERING COLUMN ADJUSTMENT CONTROL - Removal/refitting or replacement**
7. Operation complete.

Replace **ONLY** if the inspection did not pass (**NOT OK**):

Spare parts	PN	QTY
STEERING COLUMN ADJUSTMENT CONTROL	670265777	1
