Tesla, Inc. Service Bulletin		Replace Occupant Classification System (OCS) of Front Passenger Seat while Servicing Subcomponents			
SB-23-20-002 June 16, 2023		R5					
Classification		Section/Group		Mobile Service		Configuration	
Repair Bulletin		20 - Safety and Restraint		Can Perform (where permitted)		All	
Model Year		Model		Country/Region		Build Location	
2017 - 2023		Model 3, Model Y		North America, Asia Pacific		Fremont, Giga Austin	
The model(s) and model year(s) listed are a general approximation of the affected VIN list. Refer to the VIN/Bulletin Tracker or Customer/Vehicle profile to determine applicability of this bulletin for a particular vehicle.

Condition

Certain Model 3 and Model Y vehicles may need a different Occupant Classification System (OCS) installed in the front passenger seat before servicing its subcomponents.

Correction

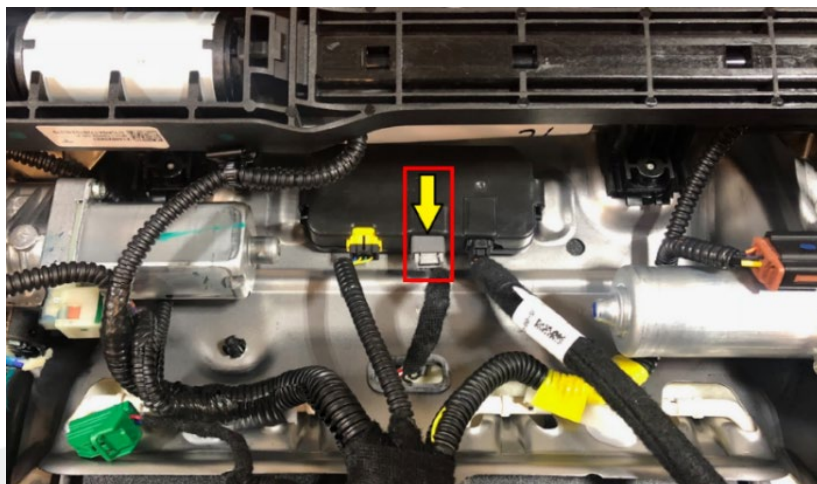
Figure 1

4. Disconnect the front passenger seat OCS sandwich sensor connector (Figure 1).

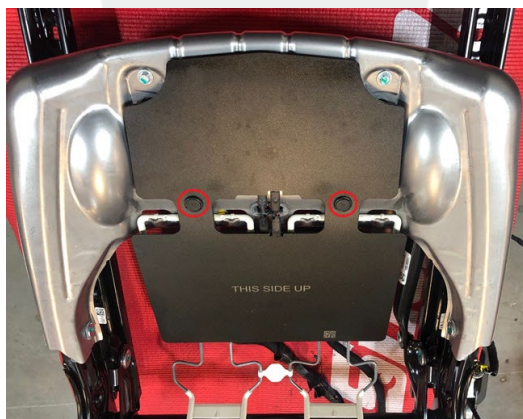
Figure 2

5. Remove the push clips (x2) that attach the front passenger seat OCS sandwich sensor to the seat frame (Figure 2).

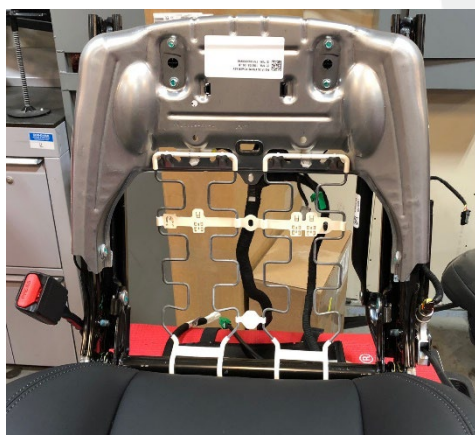
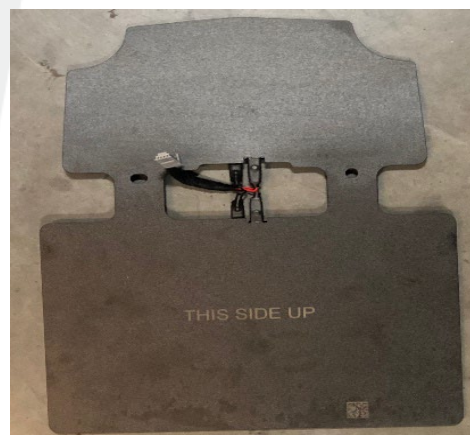
6. Remove and discard the front passenger seat OCS sandwich sensor from the seat frame (Figures 3 and 4).

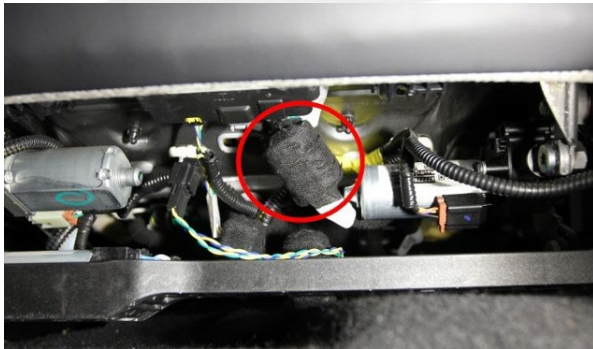
- If a ferrite is installed on the old self-capacitance electrical harness (Figure 5):

Figure 5 – Self-capacitance electrical harness with ferrite fully installed

- Remove the felt tape that attaches the ferrite to the self-capacitance electrical harness, and then remove the ferrite from the harness and set aside for reinstallation.
- Once the replacement passenger seat harness is fully installed, position the new self-capacitance electrical harness into one half of the ferrite, and then clamp the other half of the ferrite closed (Figure 6).
- Completely wrap the ferrite and self-capacitance electrical harness together with felt tape to prevent NVH issues.

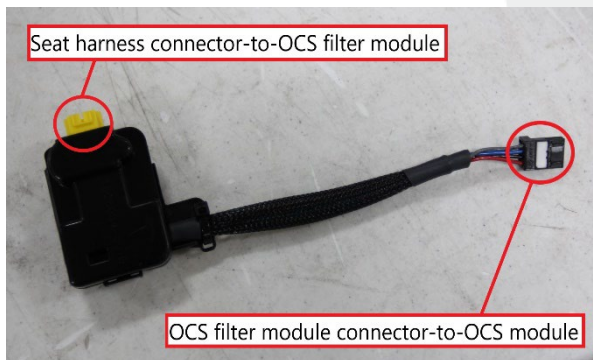
- If a passenger seat OCS filter module is installed on the seat (Figure 7), do not remove the OCS filter module from the seat. Connect the new seat harness connector to the OCS filter module (Figure 8).

Figure 7 – OCS filter module

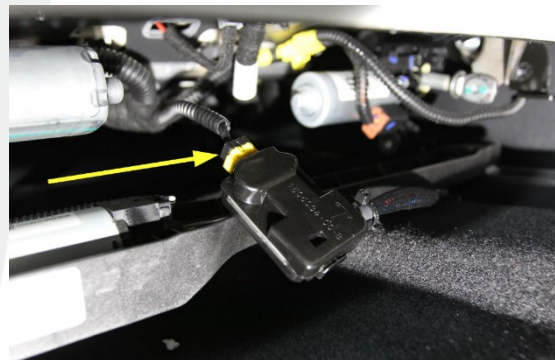
Figure 8 – OCS filter module (shown partially removed for connector clarity purposes)

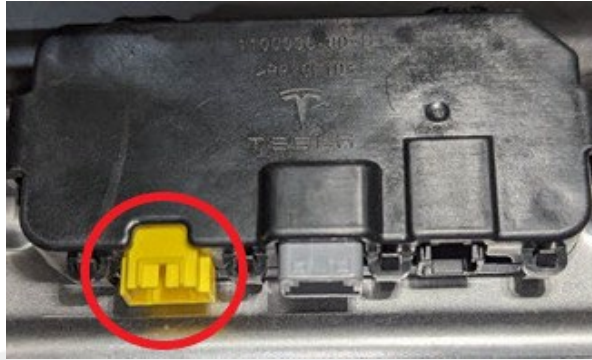
Figure 9

- Check the passenger seat module female connector (yellow port) to see if it was dislodged or misaligned during the removal of the old seat harness (Figure 9). If the connector was dislodged or misaligned, press firmly against the connector until it seats back into place.

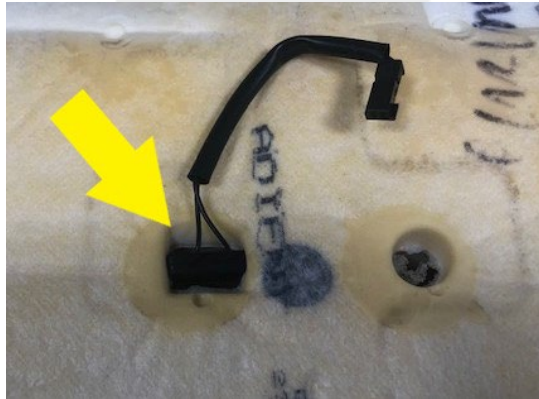
Figure 10

- Install a new RH front seat resistive occupancy sensor (part number 1099592-00-F or later), and then route the sensor connector through the foam (Figure 10).

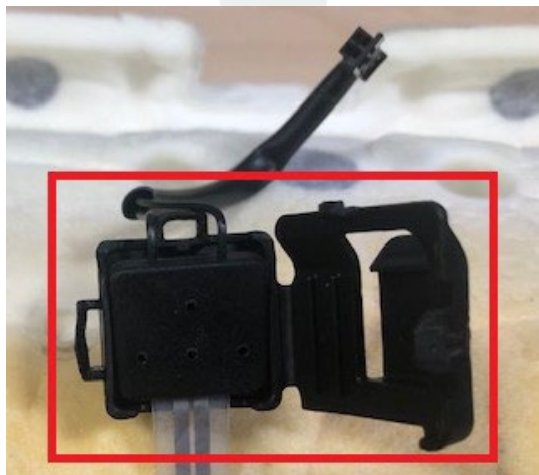
Figure 11

- Install a new RH front seat resistive occupancy sensor box clip (part number 1130363-00-B or later) (Figure 11).

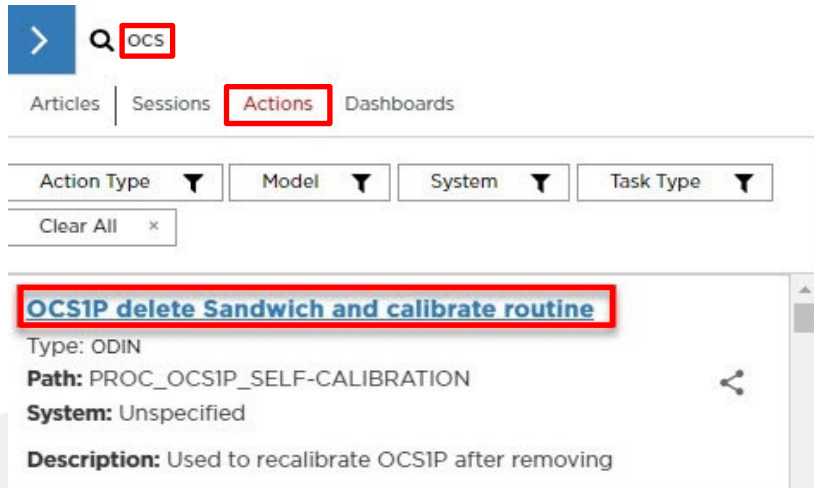
Figure 12

10. Click the **Actions** tab, search for “OCS”, and then select **OCS1P delete Sandwich and calibrate routine** (Figure 12).

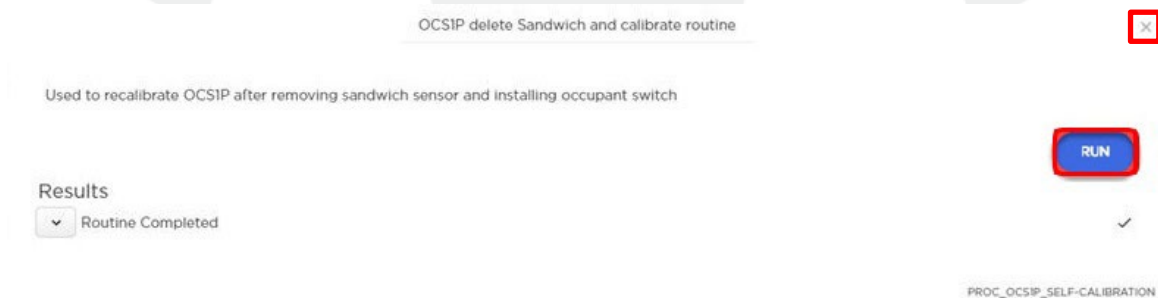
Figure 13

11. Click **Run** and allow the routine to complete. Select **X** at the top right of the window to exit once the routine is complete (Figure 13).

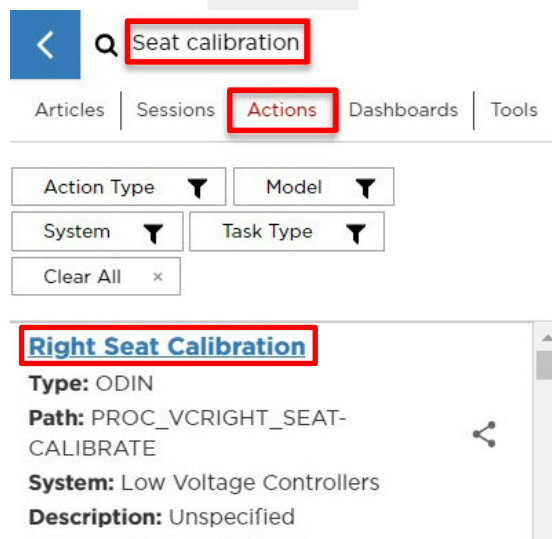
Figure 14

12. Click the **Actions** tab, search for “Seat calibration”, and then select **Right Seat Calibration** (Figure 14).

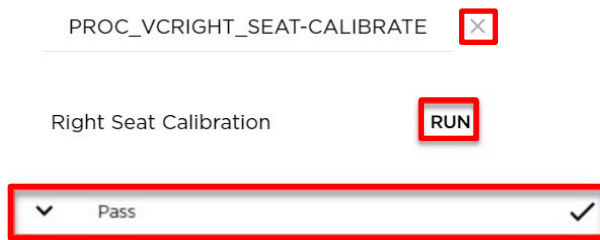
Figure 15

13. Click **Run** and allow the routine to complete. Select **X** at the top right of the window to exit once the routine is complete and "Pass" is displayed (Figure 15).
