<b>Tesla, Inc.</b> Service Bulletin		<h1 style="margin: 0;">Inspect Center Console Décor Lid Latch Pin</h1>	
<b>SB-21-15-006</b> June 16, 2023		<b>R1</b>	
<b>Classification</b> Repair Bulletin		<b>Section/Group</b> 15 - Interior Trim	<b>Mobile Service</b> Can Perform (where permitted)
<b>Model Year</b> 2021	<b>Model</b> Model S	<b>Country/Region</b> United States	<b>Version</b> All
<small>The model(s) and model year(s) listed are a general approximation of the affected VIN list. Refer to the VIN/Bulletin Tracker or Customer/Vehicle profile to determine applicability of this bulletin for a particular vehicle.</small>

Some Model S Palladium vehicles were manufactured with center console décor lid latch pins too short to reliably secure the décor lid open.

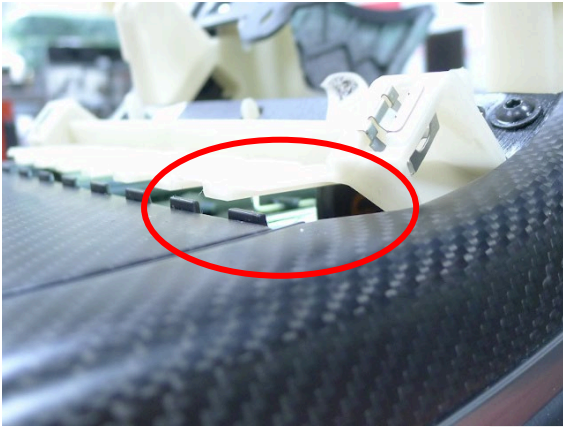
Figure 1 – Look into serrated gap here

2. Remove the center console (refer to Service Manual procedure [15192402](#)).
3. Use a flashlight to look into the serrated gap of the décor lid to determine the condition of the tang over the décor lid latch pin and if the latch pin is present (Figure 1).
  - If the tang is present and secure, but the latch pin is missing (Figure 2), install an updated latch pin. Skip to step 9.
  - If the tang is present and secure, and the latch pin is present (Figure 3), replace the latch pin with an updated component. Skip to step 6.
  - If the tang is broken off or damaged in any way (Figure 4), regardless if the latch pin is present, continue to step 4.

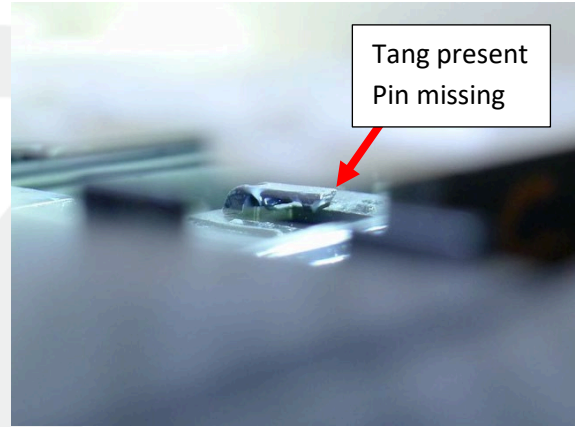
Figure 2 – Tang is present and secure, latch pin missing – Go to Step 9

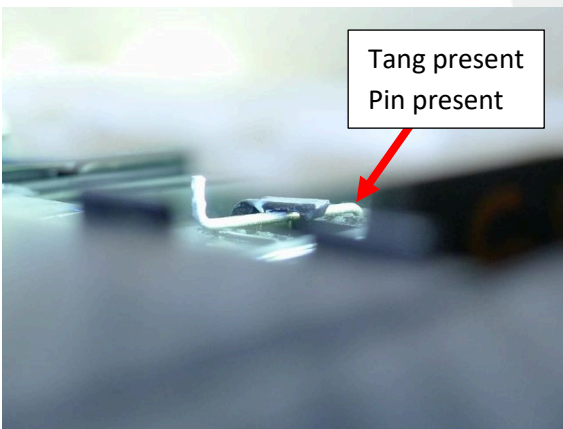
Figure 3 – Tang is present and secure, latch pin present – Go to Step 6

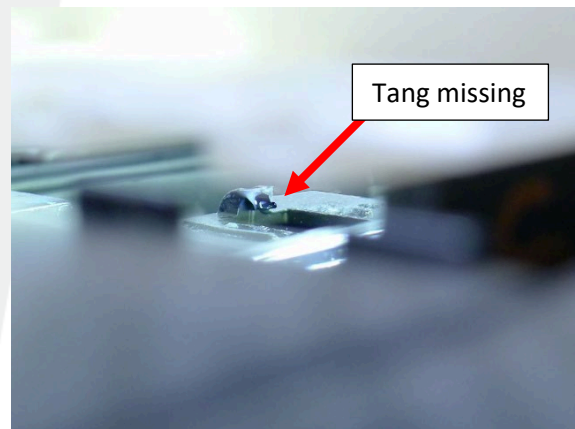
Figure 4 – Tang is broken off – Go to Step 4

4. Replace the center console décor on the center console (refer to Service Manual procedure [15190042](#)).

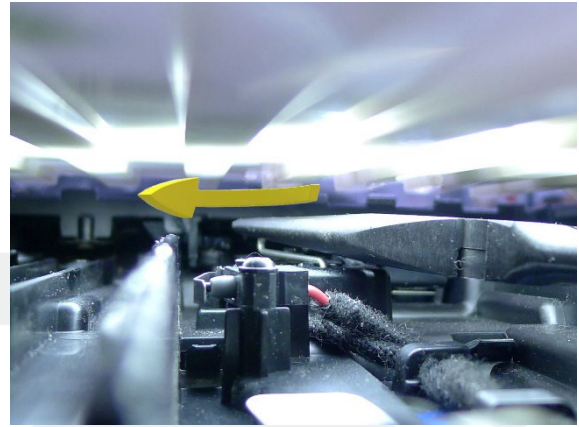
**Figure 6 – Swivel fully to the left**

- From the front of the center console (Figure 5), use needle nose pliers to swivel the latch pin to the left, out from under the tang (Figure 6).

**⚠ CAUTION:** Swivel the latch pin as far to the left as possible. If not, the tang might break in the next step. If the tang breaks, replace the center console décor. (Repeat from step 4.)

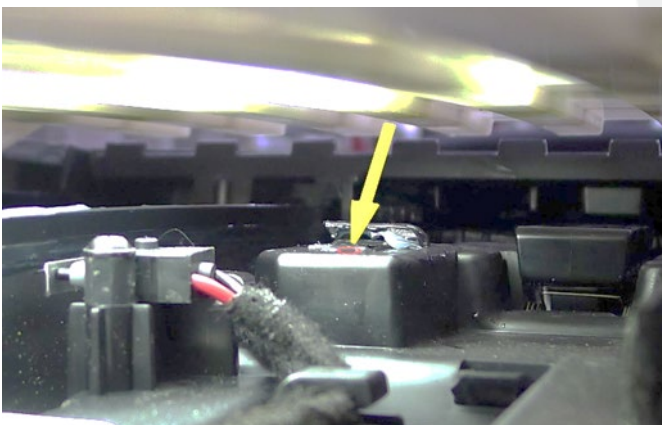
**Figure 8 – Hole in latch pin boss**

- From the front of the center console (Figure 5), use the needle nose pliers to insert the long shank of the latch pin into the hole in the latch pin boss (Figures 8 and 9).

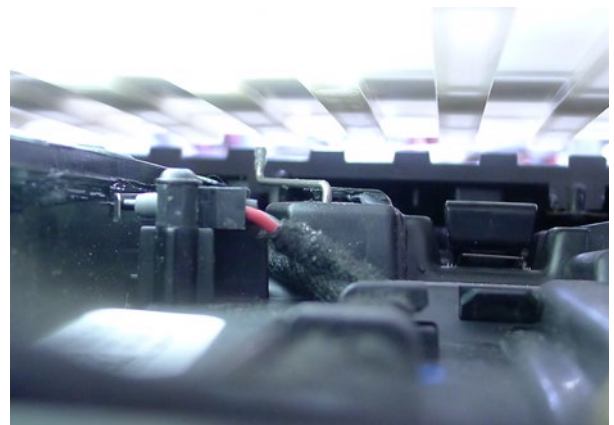
**Figure 9 – Latch pin in latch pin boss**
